**SUBJECT:** Maintenance Worker Dies when He Falls into a Baling Machine that Bales Cardboard for Recycling

**SUMMARY**  
**California FACE Report #09CA005**

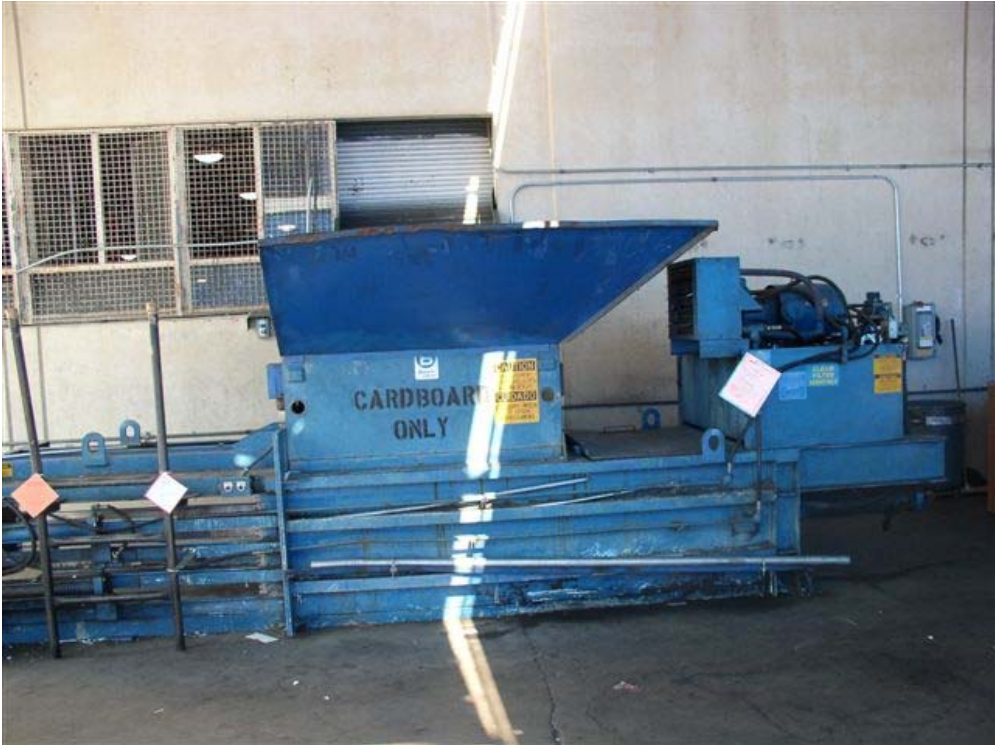
**Exhibit 1. The cardboard baler machine involved in the incident.**

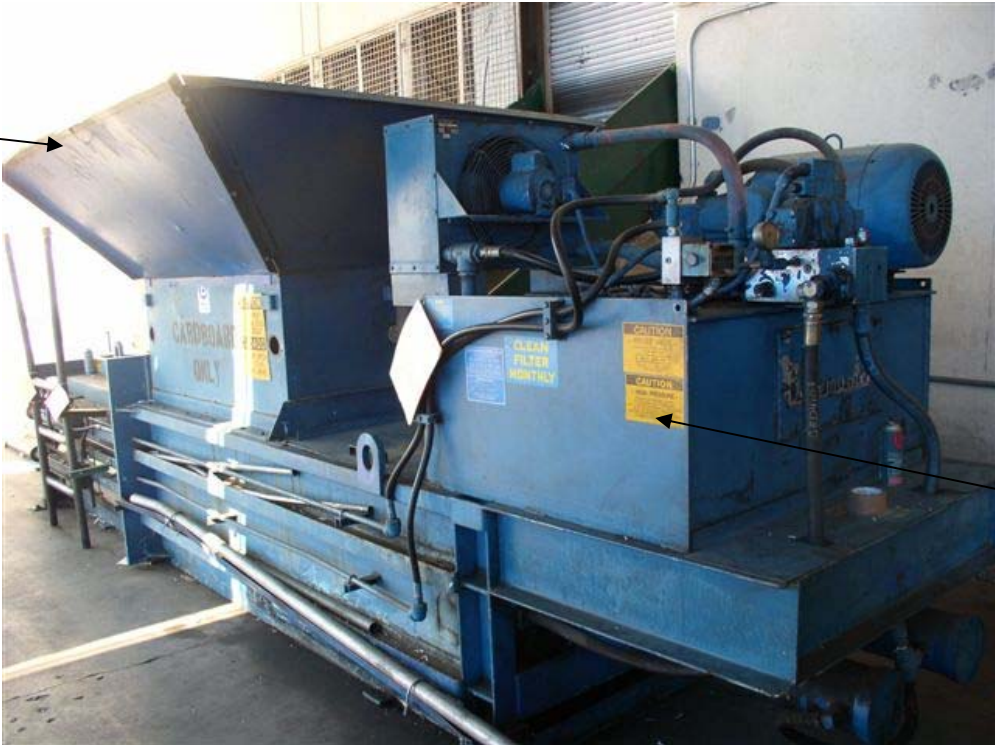
**Exhibit 2. The cardboard baler showing the hydraulic system and feed chute.**

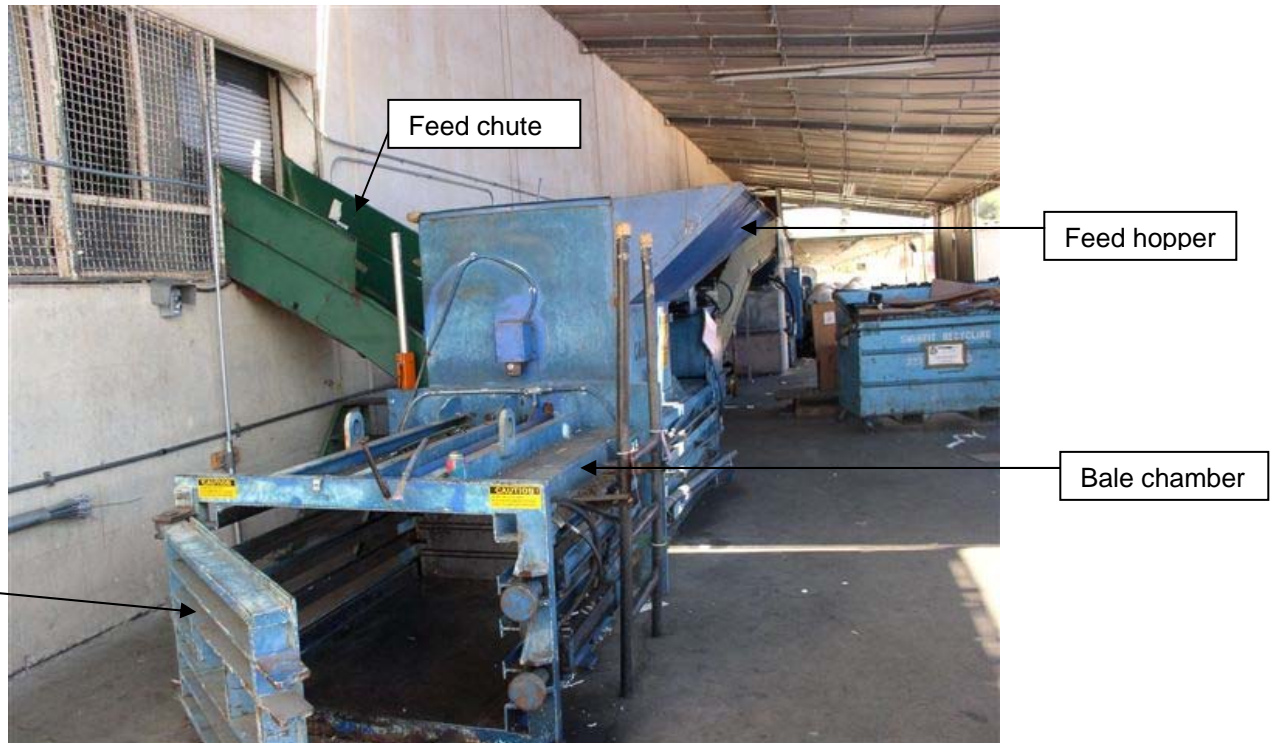
**Exhibit 3. The cardboard baler showing the feed chute and chamber where the recycled bales of cardboard were formed.**

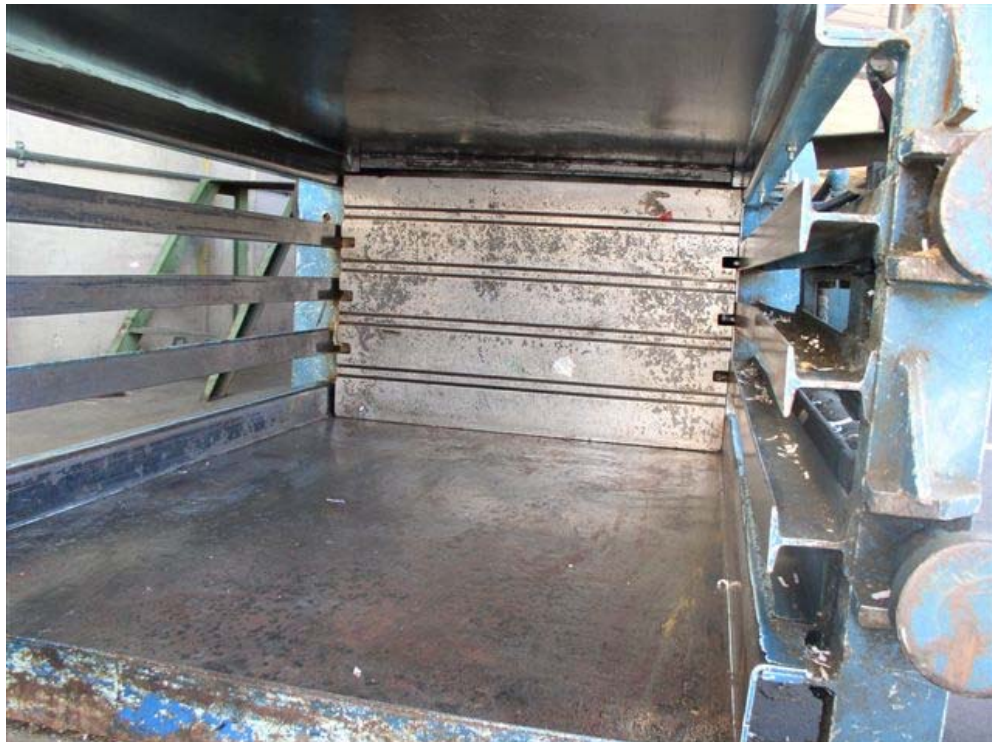
approximately 8:00 a.m., the supervisor noted that the conveyor belt that fed recycled cardboard to the machine was off. He sent a co-worker to find the victim and ask him why the conveyor belt was turned off. The co-worker approached the machine and noted that it was running in the automatic mode. He then walked around the machine and spotted the victim's hand protruding out of the bale area of the machine. He immediately shut the machine off and called 911. Fire fighters and paramedics removed the victim from the machine, and he was pronounced dead at the scene.

**Exhibit 4. The chamber where the victim was found.**

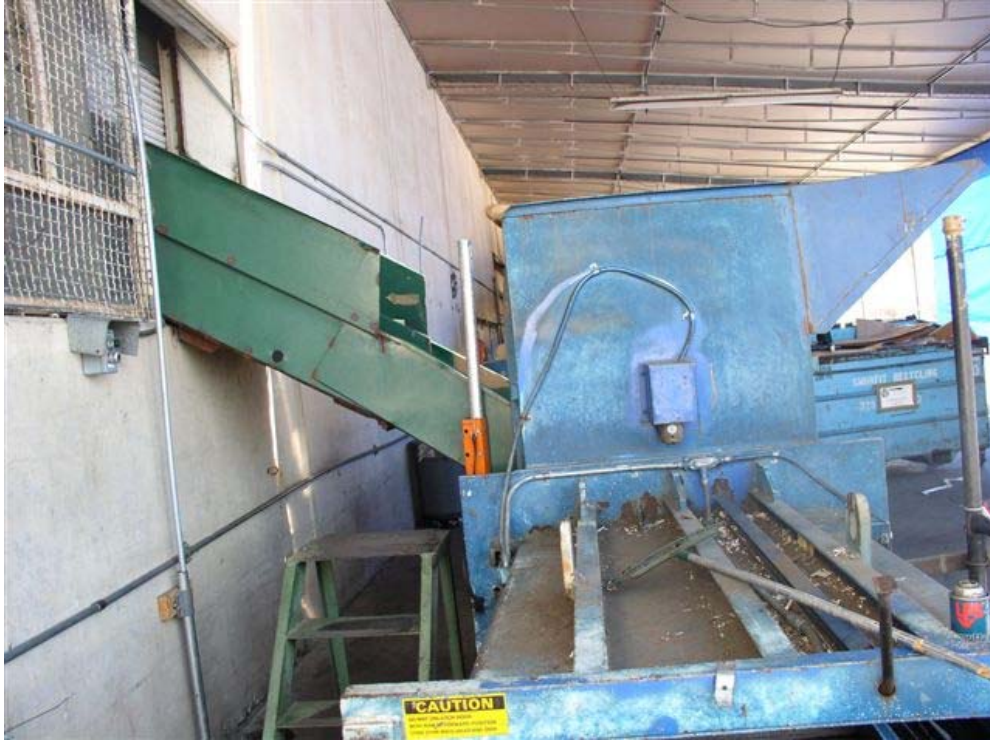
Discussion: In this incident the victim was able to gain access to the point of operation of the machine through the missing guard at the base of the chute. The victim most likely reached into the machine to either push the cardboard further into the baler or the cardboard got hung up and he was trying to free it. In either case, he most likely lost his balance and fell into the machine. Guards around the chute are necessary to prevent entry of hands, fingers, or any part of the body into the point of operation. Had this guard been in place, the victim would not have been able to reach into the machine and this incident might have been prevented.

**Exhibit 5. The feed chute with side panels missing and the three-foot step ladder used by the victim.**

### **Recommendation #1: Guards around chutes are fully enclosed to prevent entry.**

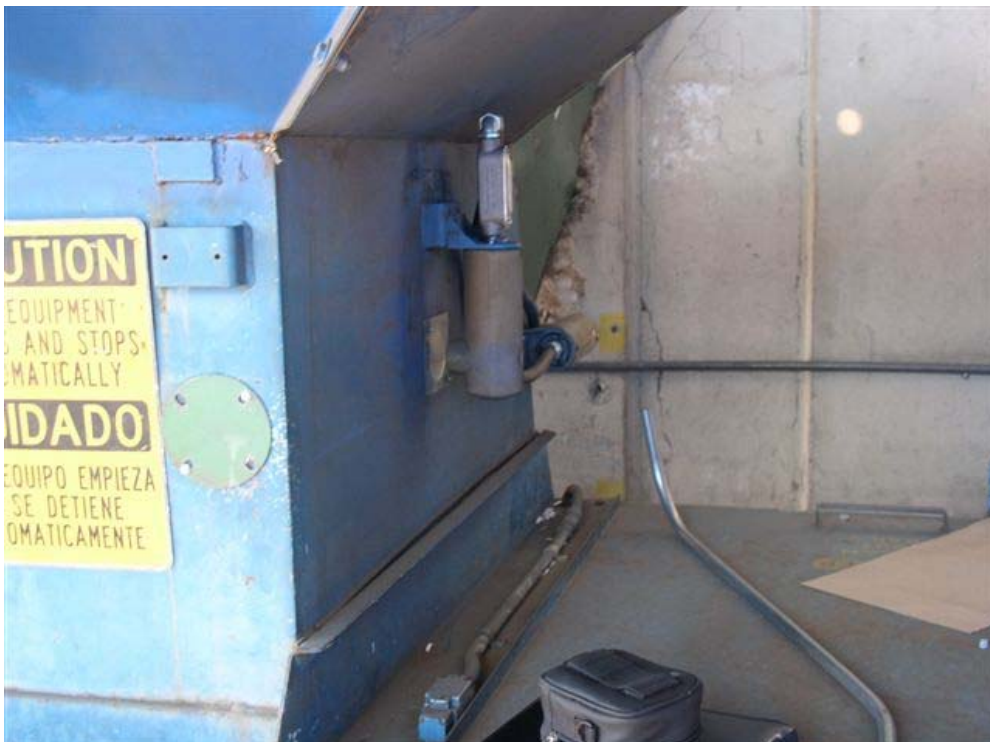
The machine involved in this incident was a cardboard baler called the "Balewel® 1600 series baler" by Balemaster®, a division of East Chicago Machine & Tool Company. This machine compacted cardboard into bales for recycling (**Exhibit 1**). The cardboard was fed into the machine through a hopper on top of the machine and a chute at the rear of the machine that received recycled cardboard off of a conveyor belt inside the warehouse (**Exhibits 3 & 5**). The chute had been constructed with side panels that did not provide total enclosure. When the machine was set in an automatic mode, the ram would automatically compress the cardboard every time it received a signal from the electronic sensors mounted on each side of the machine hopper (**Exhibits 6 & 7**).

When the cardboard being fed into the hopper reached the level of the electronic sensors, it blocked the light beam produced by the sensors, sending an electronic signal to the ram to activate. Every time the light beam was blocked, the ram would move forward and crush the cardboard into a bale. The manual mode required the operator to manually activate every action of the machine. After the cardboard was compressed into a bale, it was tied with wire and removed from the machine. According to the police report, the electronic sensors were blocked with small pieces of wood allowing the ram mechanism to continuously cycle.

Discussion: In this case, the machine was set on automatic mode. This meant that the ram that pushes the cardboard into a bale would not activate until it was sent a signal from the electronic sensors on each side of the hopper every time the light beam was blocked. According to the police report, when they did their investigation they found these sensors blocked by small pieces of wood. This meant that the ram continually cycled as the light beam was blocked. The continuous cycling of the ram crushed the victim when he fell into the hopper. Had the electronic sensors not been bypassed, the ram would have not cycled and crushed the victim.

**Exhibit 6. The electronic sensor on the feed hopper.**

### **Recommendation #2: Electronic sensors are not disabled or bypassed.**

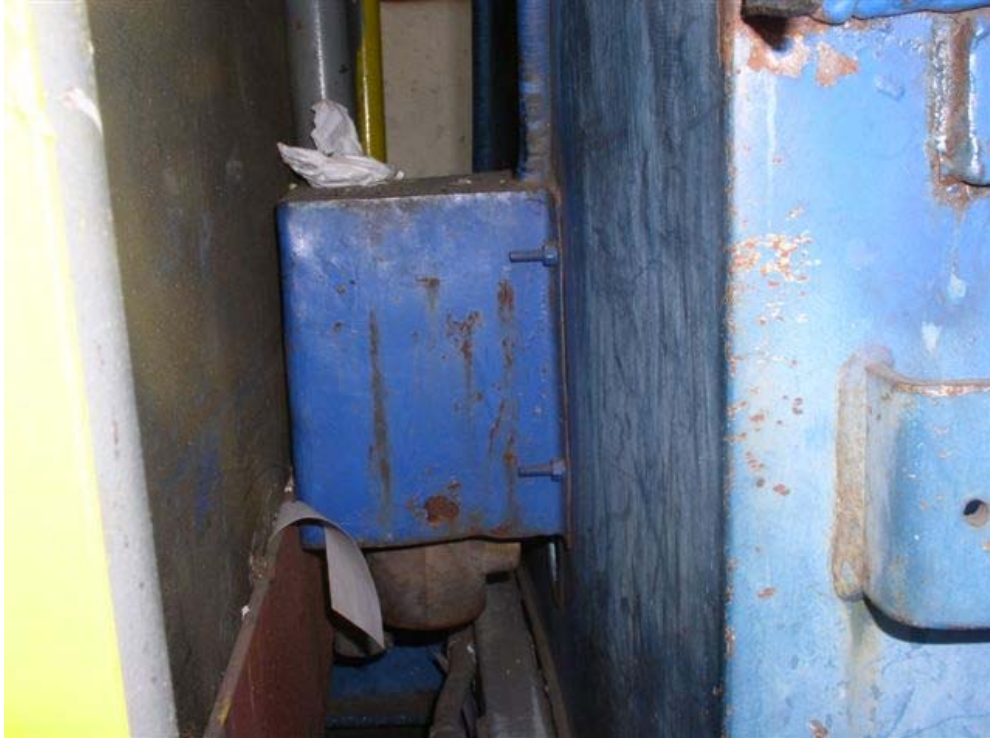
**Exhibit 7. The electronic sensor on the opposite side of the feed hopper.**
