**SUBJECT:** An Automotive Mechanic Dies from Thermal Burns when the Gasoline He was Pouring into a Vehicle Ignited

**SUMMARY**  
**California FACE Report #11CA006**

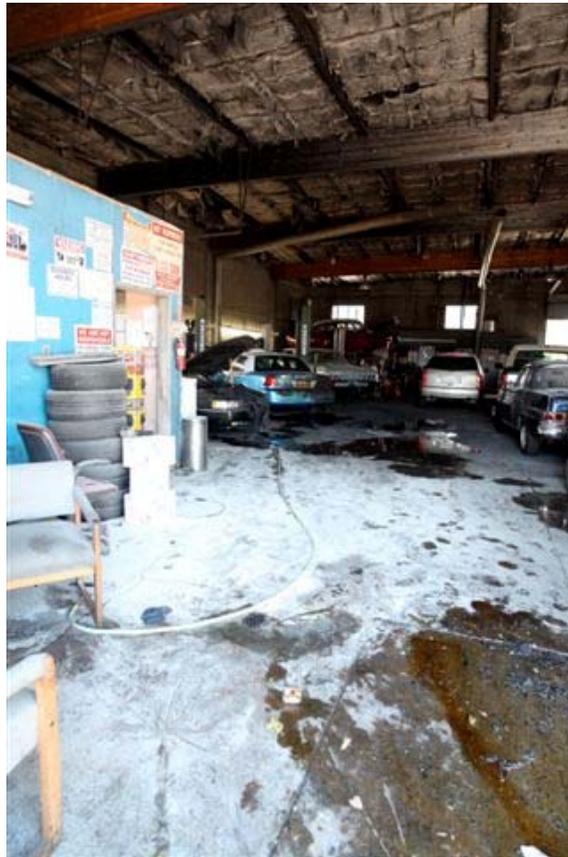
**Exhibit 1 - The incident scene viewed from the entrance to the shop.**

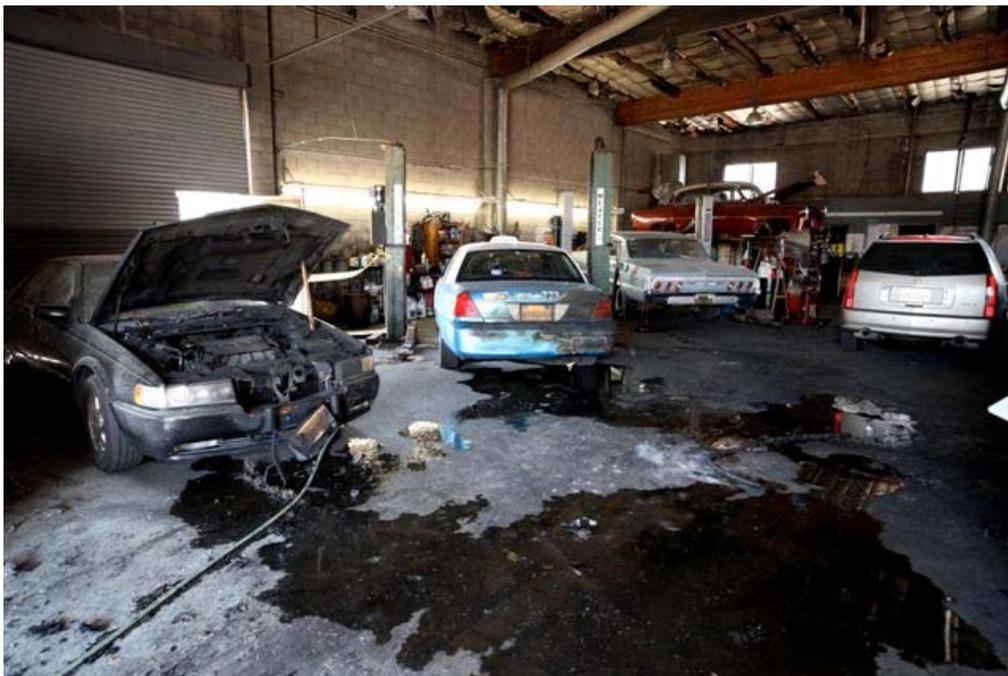
**Exhibit 2. Vehicles damaged by the fire.**

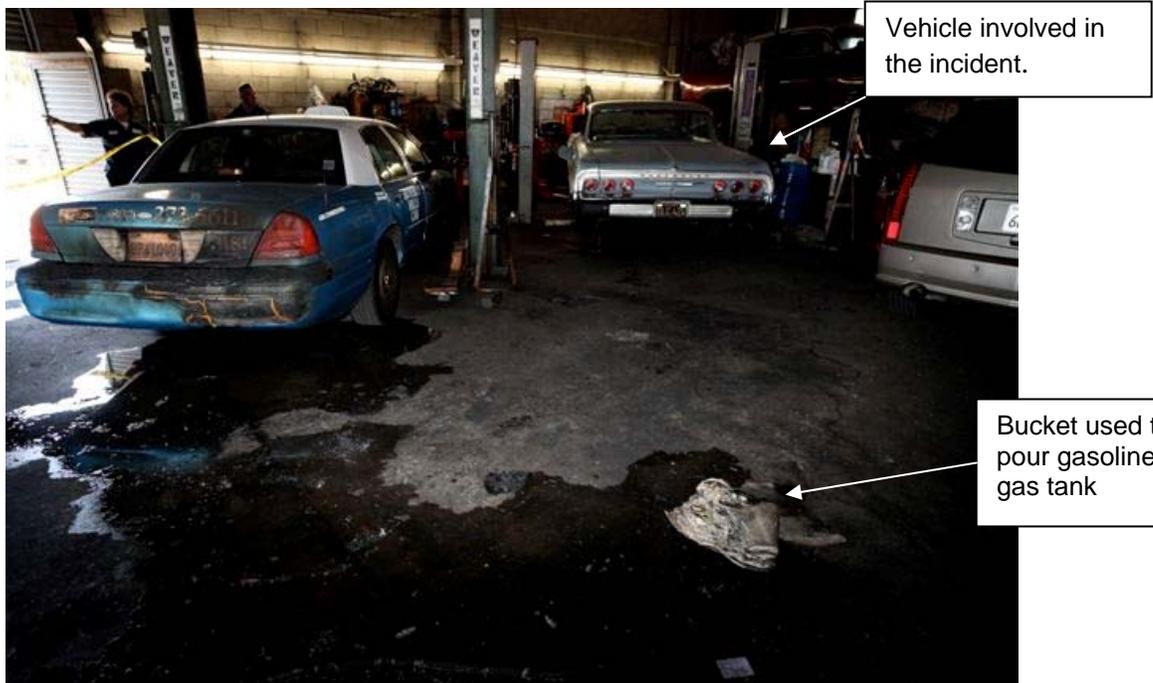
Vehicle involved in the incident.

Bucket used to pour gasoline into gas tank

**Exhibit 3. The vehicle involved in the incident.**

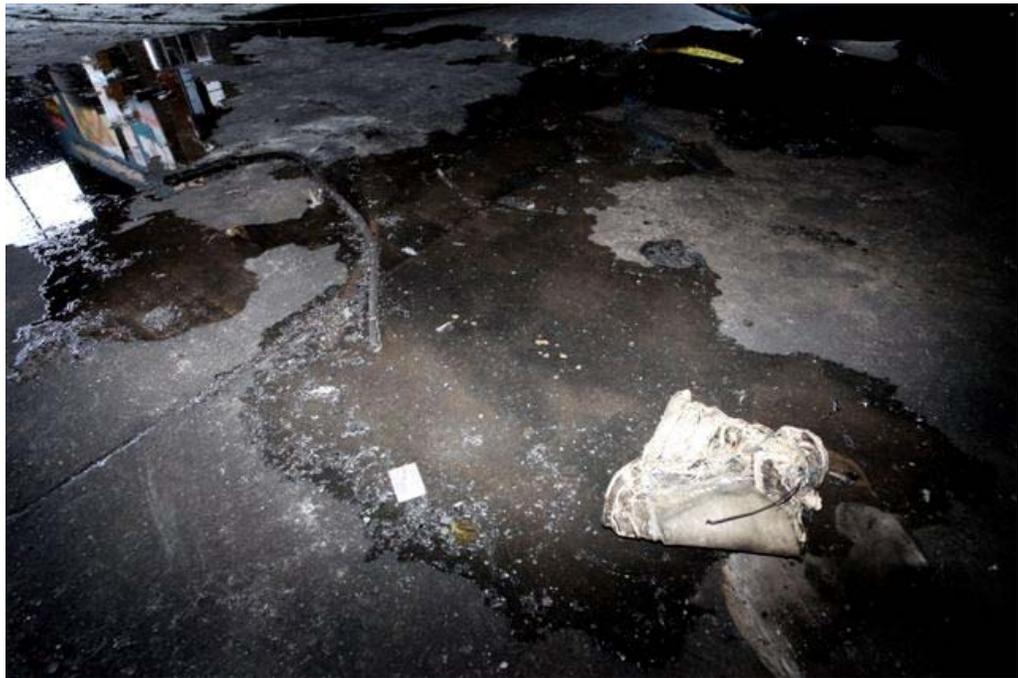
Discussion: In this incident, the victim used a plastic five-gallon bucket to refuel the vehicle. When he attempted to pour gasoline from the bucket into the vehicle, it spilled on the vehicle's tank and fender and onto the drop light hanging directly below the tank, which ignited the fuel vapors. As he ran away from the vehicle with the bucket of gasoline, he spilled fuel. This spilled fuel caught fire and then ignited the fuel in the bucket, engulfing the victim. An approved safety container equipped with an automatic closing cap and flame arrester prevents fuel from splashing out and flames from getting in. Had the victim used an approved container, the fire might have still occurred, but the container would have been protected and he probably would not have suffered fatal injuries.

**Exhibit 4 - The remains of the bucket used to pour gasoline into the vehicle.**

**Recommendation #2: When refueling vehicles with a portable container, the container should be equipped with an automatic closing cap and flame arrester.**

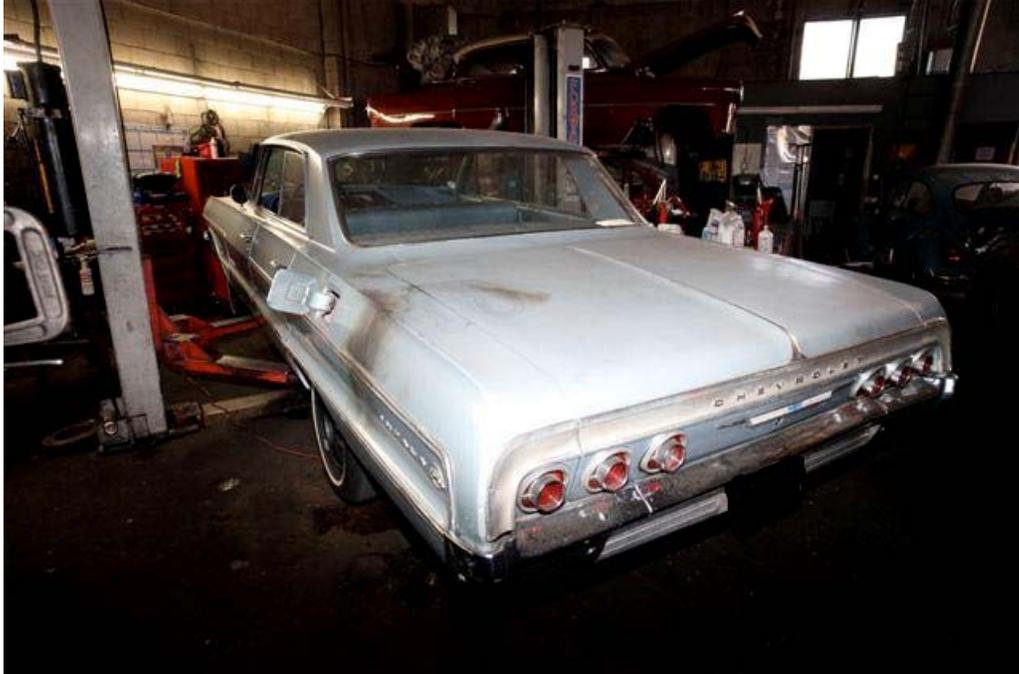
**Exhibit 5 - The vehicle involved in the incident.**

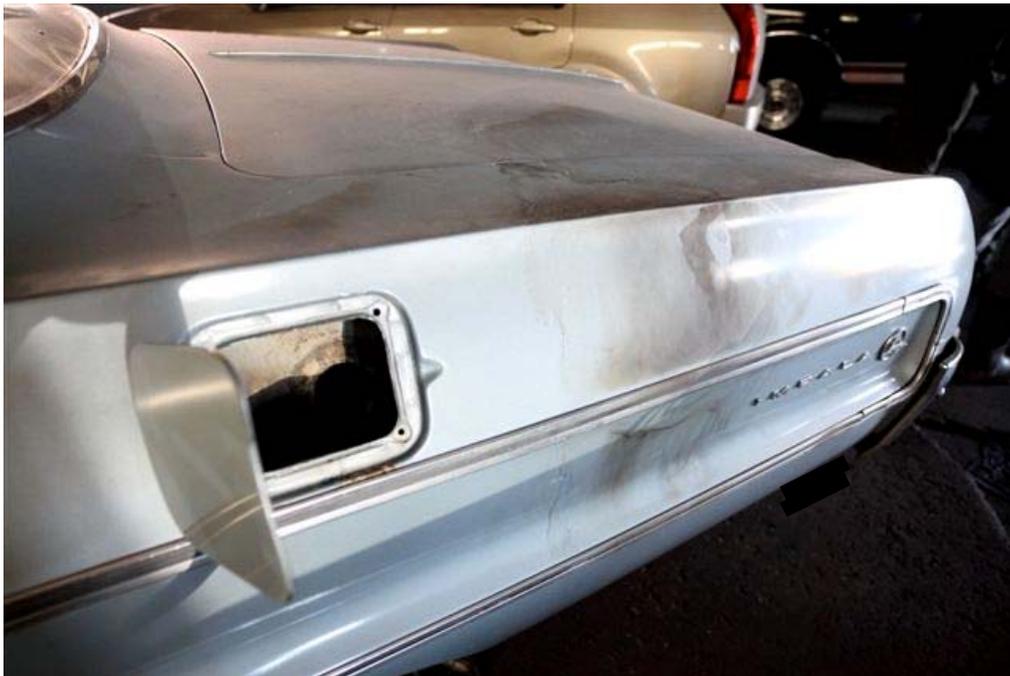
**Exhibit 6 - The vehicle's fuel tank inlet.**

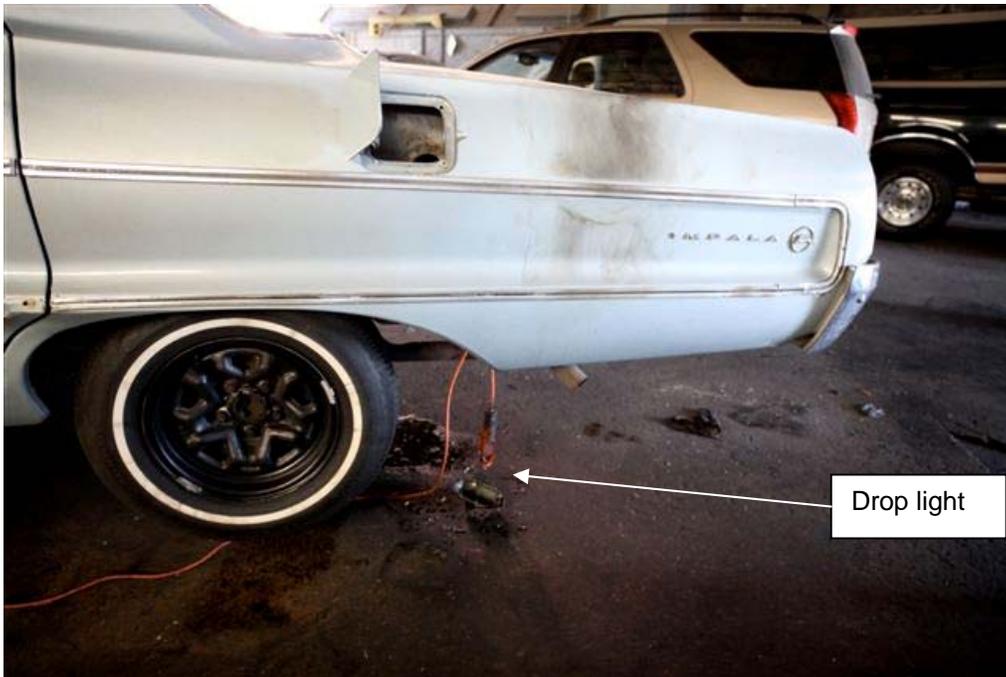
Discussion: In this incident, the victim was using a drop light with an incandescent light bulb under the vehicle while it was raised on the lift. The drop light was still under the vehicle when he lowered the lift. When he attempted to pour gasoline into the vehicle's gas tank, it spilled onto the drop light and immediately ignited. When lowering an automotive lift, the area under it should always be kept clear of tools, parts, and materials so as to avoid any damage to the item, the vehicle on the lift, or the lift itself. If illumination is absolutely required in proximity to a fueling operation, an explosion/ignition-proof or intrinsically safe drop light should be used. Explosion/ignition-proof lights enclose the bulbs in a case that can withstand the force of the bulbs exploding and they prevent substances from reaching the bulbs where high temperatures might cause them to ignite. Intrinsically safe lights do not reach the temperatures or allow the sparking necessary for fuel ignition. If the victim used this type of drop light or had removed the drop light from under the vehicle prior to lowering the lift, this incident could have been prevented.

**Exhibit 7. The drop light that was left hanging under the vehicle when the automotive lift was lowered.**

**Recommendation #1: Sources of ignition are eliminated when work involves flammable liquids.**

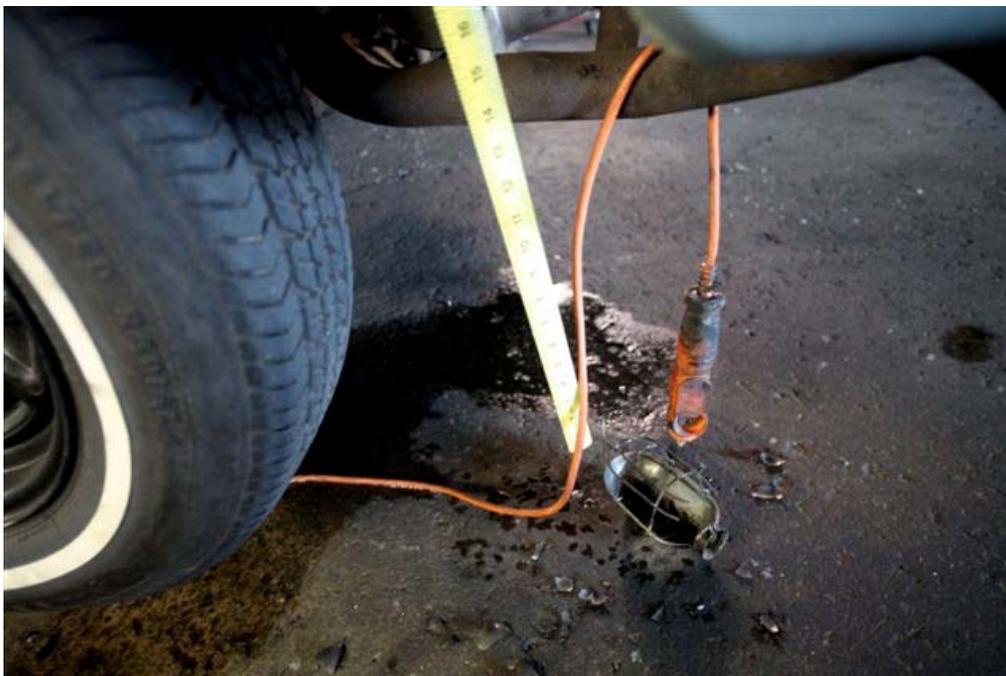
**Exhibit 8. Close-up of the drop light.**

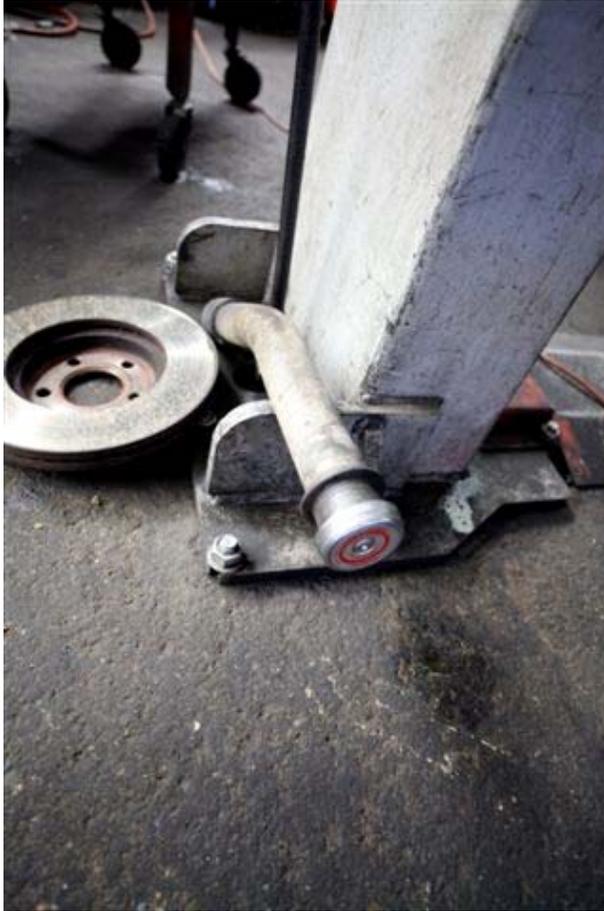
Discussion: In this incident, the victim installed a new gasoline tank in a vehicle but didn't attach the filler hose from the tank to the vehicle. A filler hose is important to the refueling process because it provides a safe and direct route to the tank where the likelihood of spillage would be minimal. Without a filler hose, the fuel would splash over the tank and fender of the vehicle allowing gasoline vapors to escape and possibly ignite if there is an ignition source close by. Had the victim inspected his work prior to adding fuel to the tank, he would have noticed the missing filler hose and likely prevented this incident.

**Exhibit 9. The gas tank filler hose.**

**Recommendation #3: Gas tanks are properly installed before refueling.**

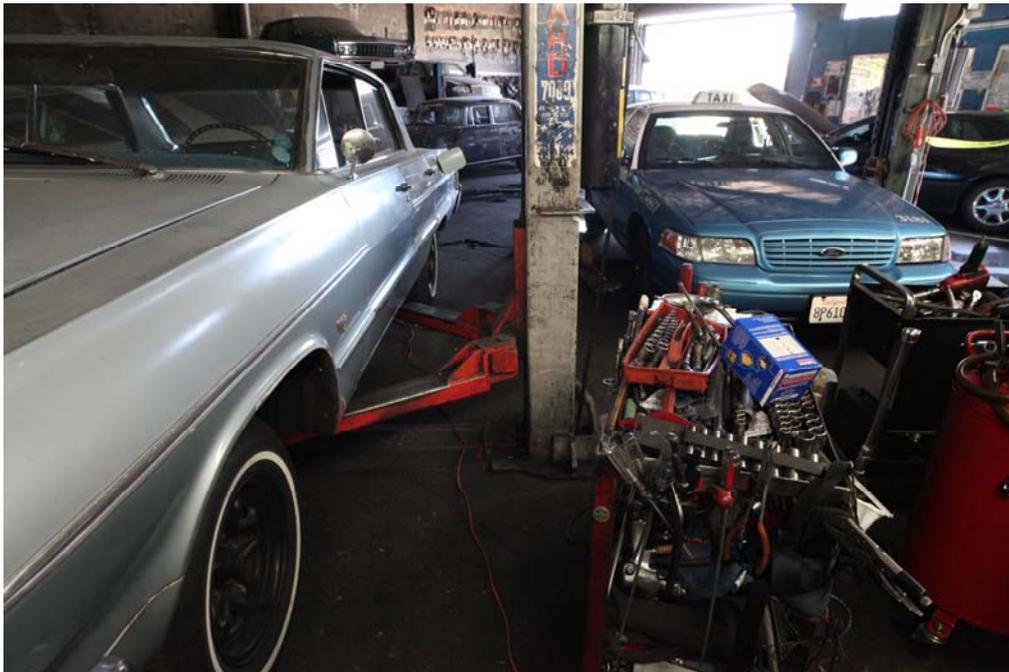
**Exhibit 10. The distance from the vehicle to the shop's main entrance.**
