FROM: California Fatality Assessment and Control Evaluation (CA/FACE) Program

SUBJECT: A Tree Trimmer Dies When He is Crushed by Palm Tree Fronds

SUMMARY
California FACE Report #12CA006

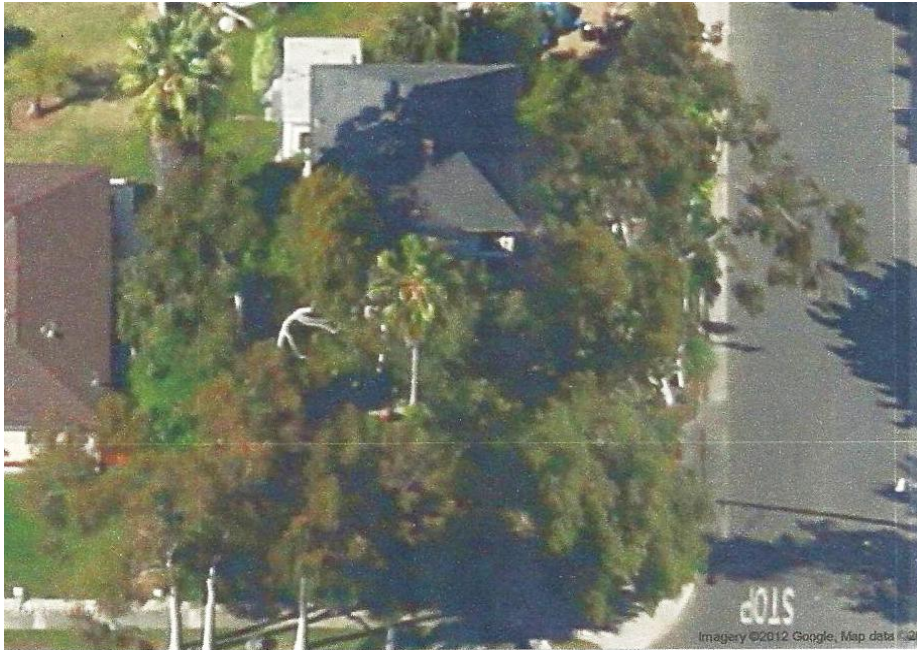
The palm tree involved in the incident.

Exhibit 1. An aerial view of the private residence where the incident occurred.

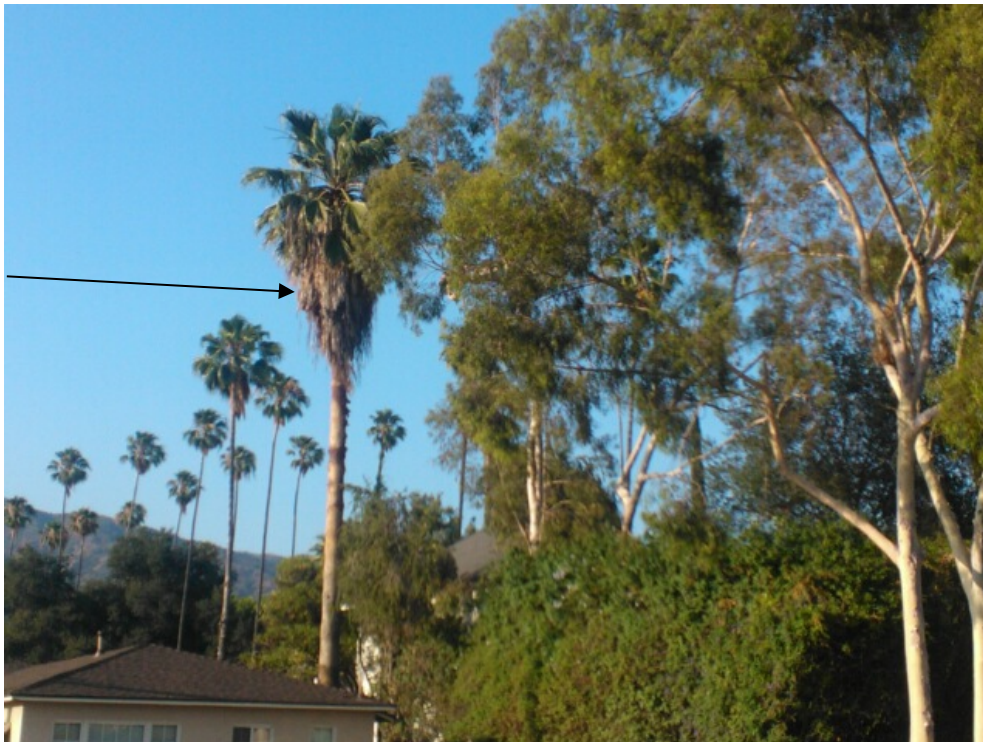
The palm tree involved in the incident.

Exhibit 2. A street view of the palm tree involved in the incident.

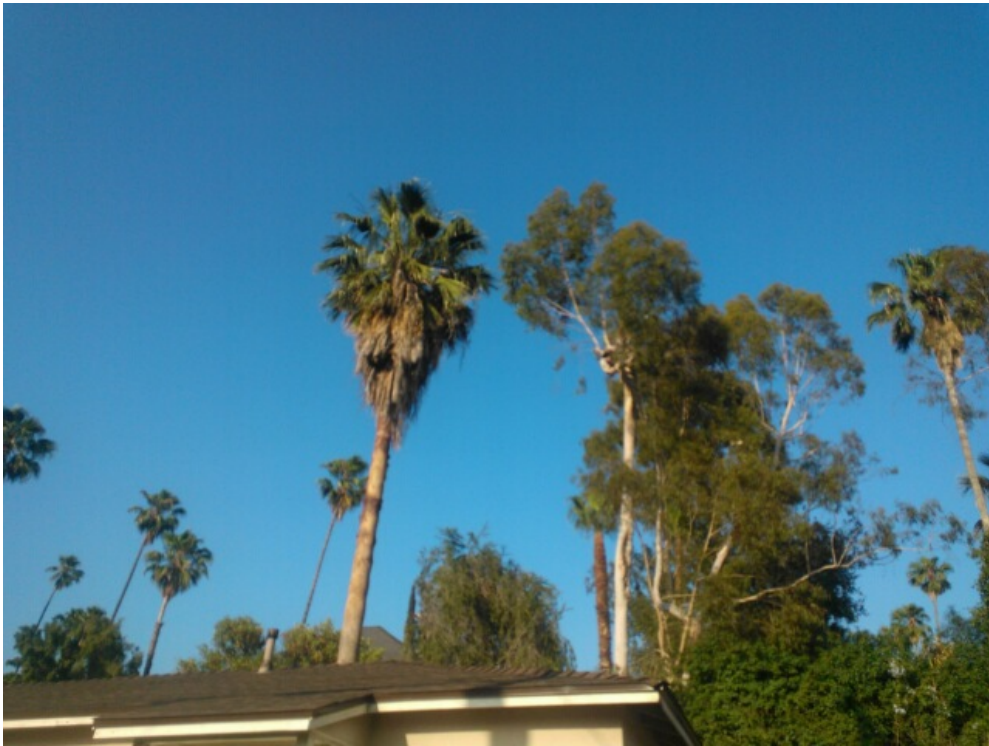
Exhibit 3. A view of the palm tree from the neighbor's driveway.

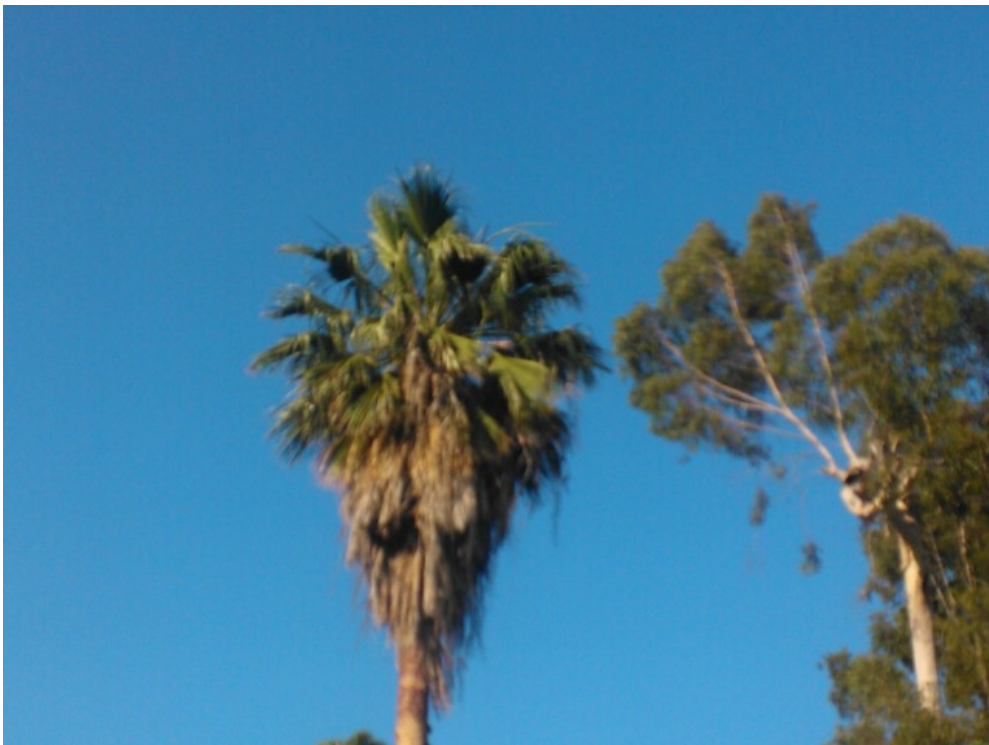
Exhibit 4. A close up of the palm tree involved in the incident.
