**FATALITY ASSESSMENT AND CONTROL EVALUATION
PROGRAM (CA/FACE)**

**Lake Maintenance Worker Drowns while Removing
Weeds from a Golf Course Lake
Case Report: 15CA001**

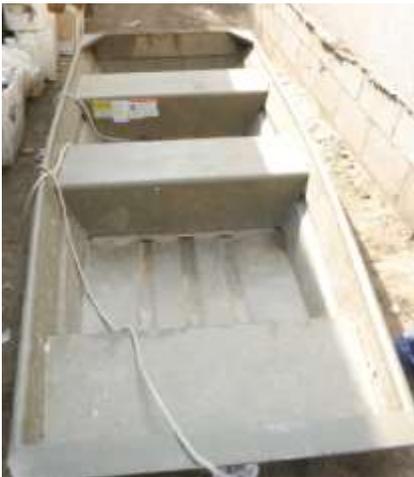
Exhibit 3. Boat used by victim

The victim was not wearing a PFD and there was no rescue equipment in the boat or onshore. Witnesses reported that the square-nosed boat that was being used that day may have contributed to the instability of the craft, leading up to the boat capsizing and the victim falling into the water. The boat involved in the incident was being used temporarily while their other boat was being repaired. The square-nose and shallow-hull design allows weeds to build up in front of the boat, impeding movement and requiring the boat operator to clear the weeds from the front of the boat, often from a standing position. Shifting one's weight in such a manner changes the center of gravity, decreasing stability. It was reported that the victim may have been clearing weeds from the boat's path when it overturned. There is inconsistent information as to whether the victim knew how to swim. During the CA/FACE interviews, the employer and

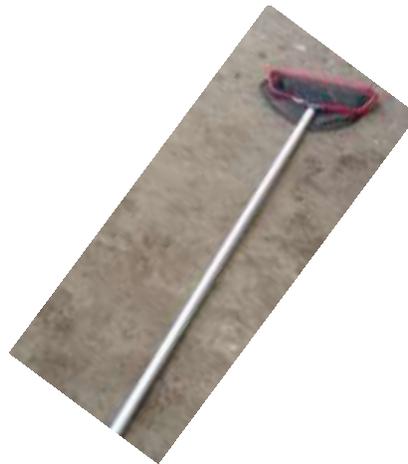
Exhibit 4. Poled net used for paddling the boat

Discussion: The victim was using a long pole with a net (skimmer) as a means for propelling the boat through the water. This pole and/or the rope used to corral the weeds may have become caught on weeds, or contributed to the instability of the boat, causing it to capsize. Employers should provide proper equipment for navigating non-motorized watercraft. Using proper equipment, such as strong and adequately sized paddles or oars, helps with controlling and navigating small watercraft safely.

Recommendation #5: Provide proper equipment for navigating small non-motorized watercraft.

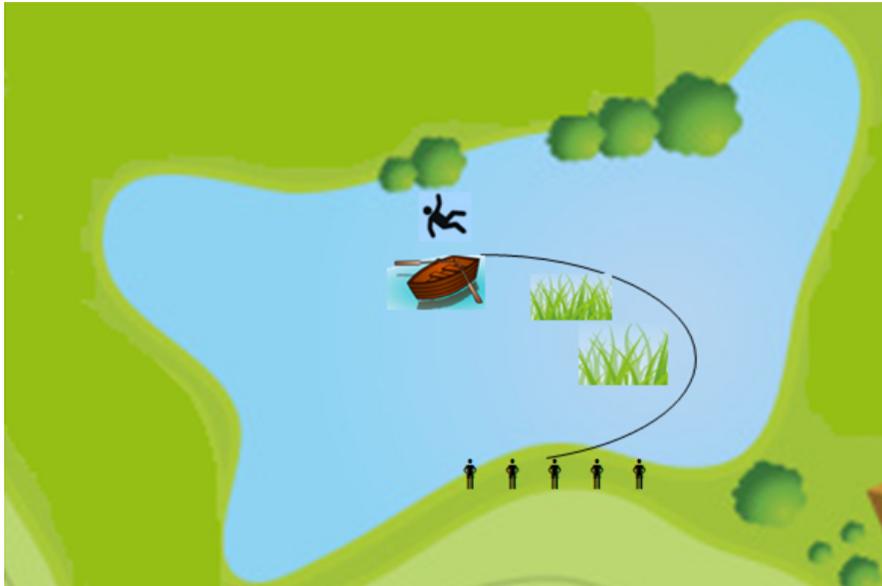
On the day of the incident, the victim was working from a small boat while “corralling” weeds from a golf course lake maintained by the victim’s employer. Corralling is an in-lake management method used for gathering floating weeds and moving them to the shoreline for disposal (Exhibit 5). During this procedure, a rope is attached to the boat and secured to the shore; the person in the boat takes the line out and surrounds the weeds in a large circular pattern and returns to shore. According to coworkers, the rope is allowed to sink to the bottom, at which time the workers onshore pull the rope, extracting (culling) the underwater weeds, and bringing them closer to the shoreline where they can then be raked onto the shore for disposal.

Exhibit 5. Graphic depiction of corraling activity leading up to the fatal incident (not to scale).
