**FATALITY ASSESSMENT AND CONTROL EVALUATION PROGRAM
(CA/FACE)**

**A Heating, Ventilation, and Air Conditioning (HVAC) Contractor
Dies When He Falls Through a Skylight
Case Report: 16CA005**

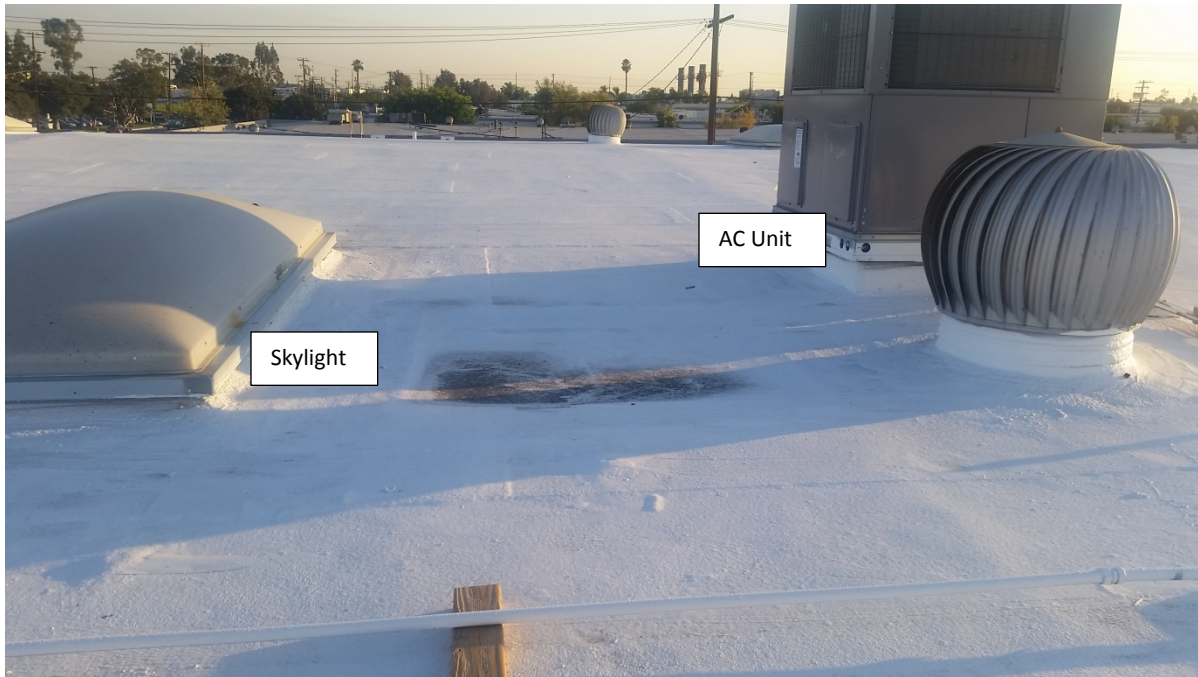
After completing a survey of the electrical panel, the victim climbed up a fixed exterior ladder on the back side of the warehouse to gain access to the flat roof of the building. He then traversed over to one of the AC units to inspect the components to determine whether additional duct work was possible. Another contractor was working below (inside the warehouse), completing the finishing touches on the theme rooms. He stated that all of a sudden he heard a scream and a crashing noise that came from one of the other theme rooms. He hurried over to the room and found the victim lying on the concrete floor underneath the broken skylight. He then went to the front office to inform the owner and called 911. Both the owner and contractor stayed with the victim until emergency medical services arrived. The victim was transferred to a local hospital where he succumbed to his injuries 19 days later.

Exhibit 2. The incident scene.

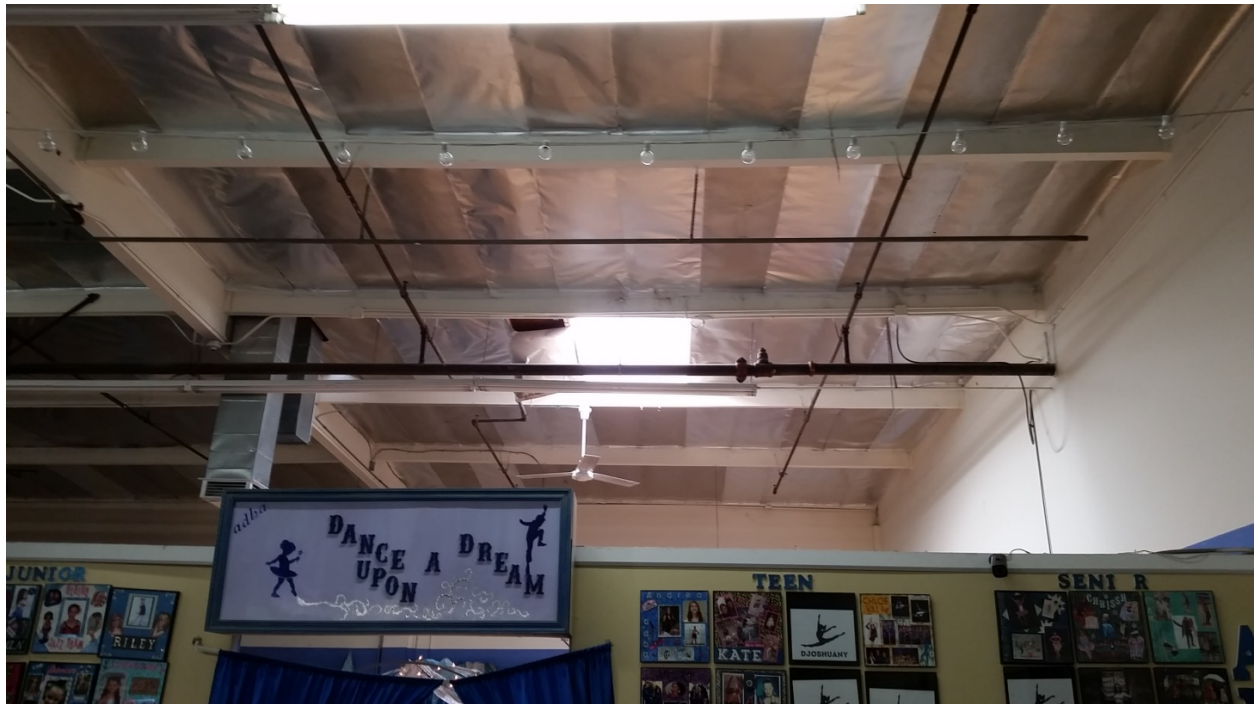
Discussion: In this incident, the skylight in close proximity to the AC unit created a serious safety hazard. Although the job was of short duration, the victim was still at risk in the event he fell onto the skylight cover. The skylight's plexiglass fixture can and should be designed to serve the function of providing ambient outdoor light into a building, while having sufficient strength to support at least twice the weight of employees, equipment, and materials that may be imposed on the cover at any one time. Architects, engineers, and employers should work together to ensure that skylight fixtures specified in the building plan meet this strength requirement. These skylight fixtures should be permanent and of sufficient strength to protect workers who access the roof from inadvertently falling through them. Until adequate design requirements are in place and skylights installed to protect workers from falling through them, HVAC contractors may not know if the skylights in their work area can support their weight. Therefore, HVAC contractors need to ensure that safety nets, screens, covers, or guardrails are in place around skylights in the immediate work area. Had the building owner installed these protective barriers around the skylights, this incident could have been prevented.

Exhibit 3. The dance studio theme room skylight opening involved in this incident.

Recommendation #2: Ensure that building owners install safety nets, screens, covers, or guardrails around skylights within six feet of HVAC equipment.
