**FATALITY ASSESSMENT AND CONTROL EVALUATION PROGRAM
(CA/FACE)**

An 18-Year-Old Laborer Dies When Pulled into a Clay Moulding Machine (Pug Mill)
Case Report: 18CA003

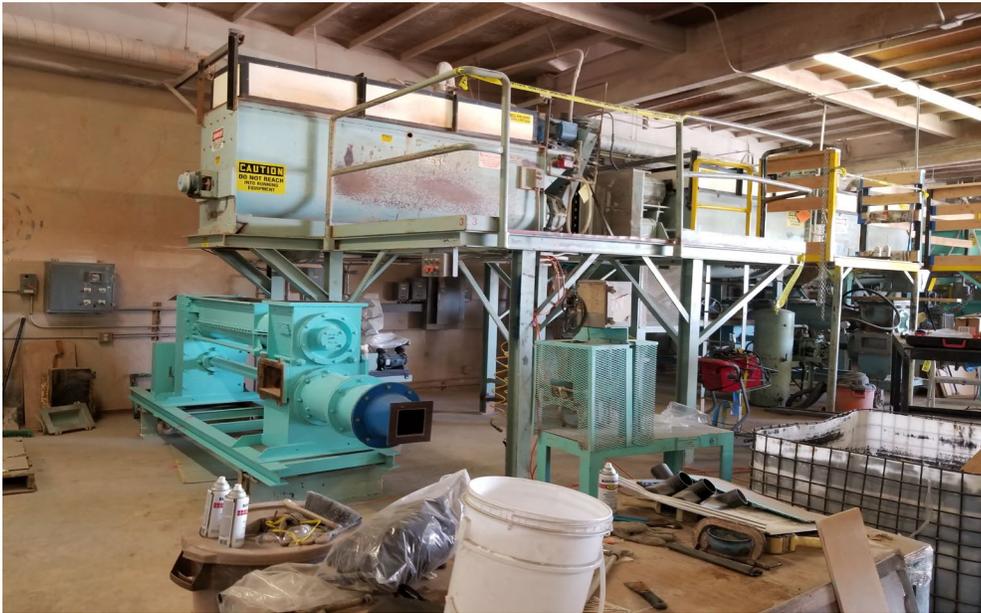
The machine involved in this incident was a Walter C. Stoll and Sons pug mill and extruder (Model #SE10) that was originally manufactured in 1998. The employer had purchased this machine secondhand in 2000. During operation, a clay mixer drops the clay material (using gravity) into an auger compartment to mix and push the clay into a vacuum chamber to remove moisture. The clay is then moved into an extruder that pushes and squeezes the clay into a mold to form the desired shape requested by a customer. The auger compartment contains a rotating shaft with sharp blades (Exhibit 2) that push the clay into the vacuum chamber.

Exhibit 1. A pug mill identical to the one involved in the incident.

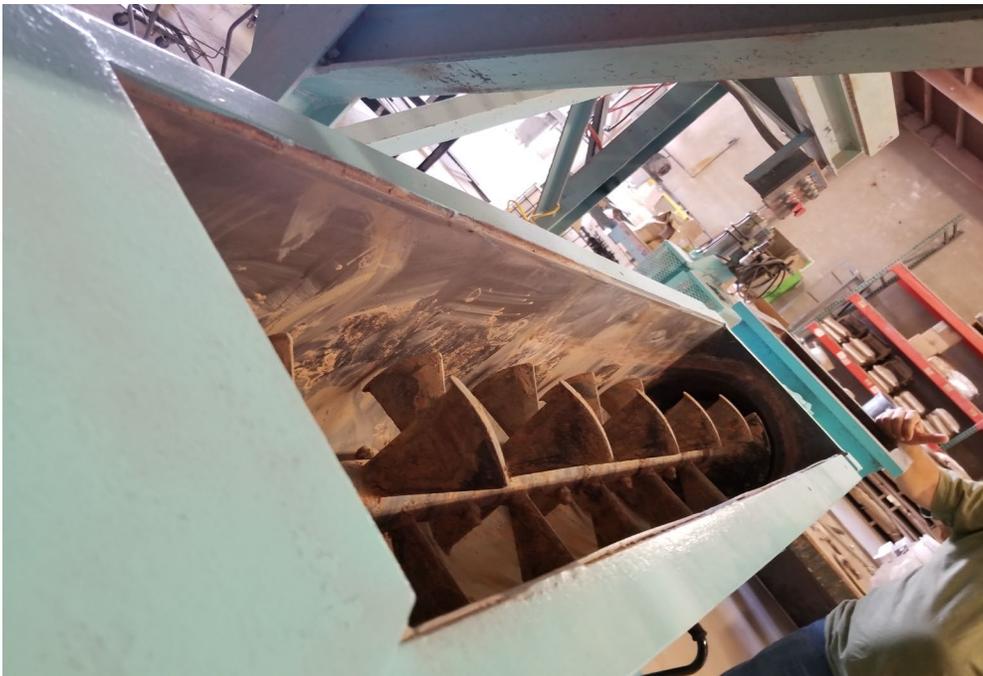
On the day of the incident, the victim was working with his stepbrother who was one of the machine operators. At approximately 11:00 a.m., his stepbrother went to assist another operator. The incident was not witnessed, but employer surveillance video showed the victim walking over to the machine involved in the incident. According to the police department report, the recorded footage appeared to show that the victim was scraping the dry clay off the edges of the unguarded auger compartment when his left arm was pulled into the blades.

Exhibit 2. The auger blades.

Recommendation #1: Ensure that machinery with moving parts is properly guarded.

Discussion: In this incident, the victim was removing clay from the auger compartment that was not guarded. Although the original manufacturer's model had a chute and guard around the auger compartment, this was not in place on any of the pug mills while the victim was working. The original guard around the auger compartment was designed to prevent employees from reaching into the compartment while the pug mill was in operation. The victim was able to easily reach into the auger compartment and, in so doing, he became entangled and died. Even if the employer had purchased the pug mill without the original guard, secondary guarding could have

been installed to prevent employees from reaching into the compartment and becoming caught in the auger blades. The employer installed a gate around the compartment after the incident occurred, such that the pug mill shuts down after opening. Electronic sensors can also be used to protect employees from moving parts and pinch points, as they shut down the machine whenever the sensor beam is broken. If the employer had ensured that there was guarding around the auger compartment, the victim would not have become entangled in the rotating blades.

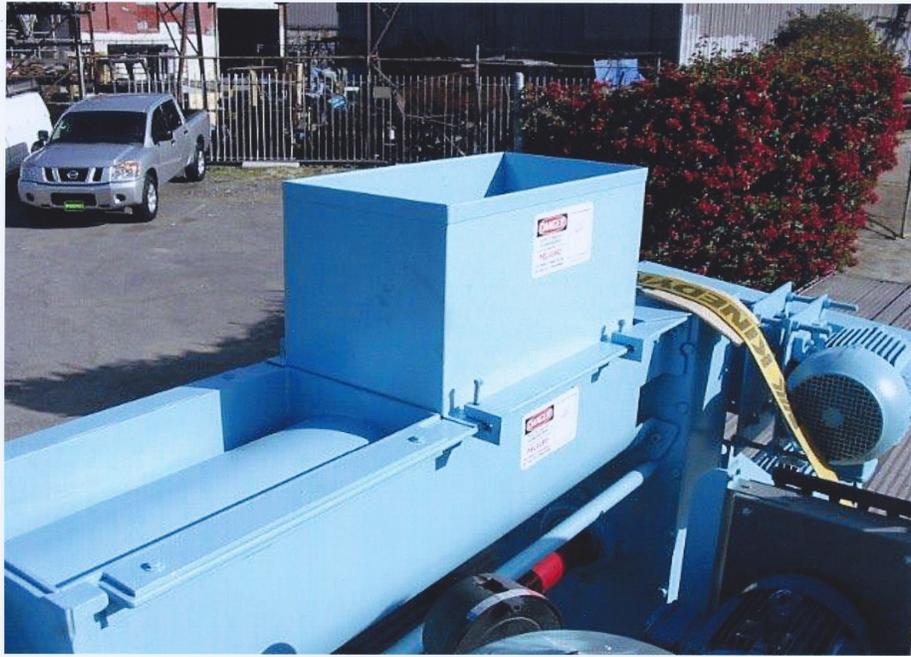
According to the manufacturer, the original equipment was sold with a chute from the mixer that enclosed the auger compartment (Exhibit 3). However, the employer installed this machine (as well as the other three pug machines) without the chute such that the auger compartment was not enclosed and had no guarding to prevent employees from reaching in. It is not known if the employer purchased the secondhand pug mill with an enclosure around the auger compartment.

Exhibit 3. A pug mill with safety chute covering the auger blades.
