**FATALITY ASSESSMENT AND CONTROL EVALUATION PROGRAM  
(CA/FACE)**

A mechanic died when the multi-piece tire and wheel he was removing exploded.  
Case Report: 19CA004

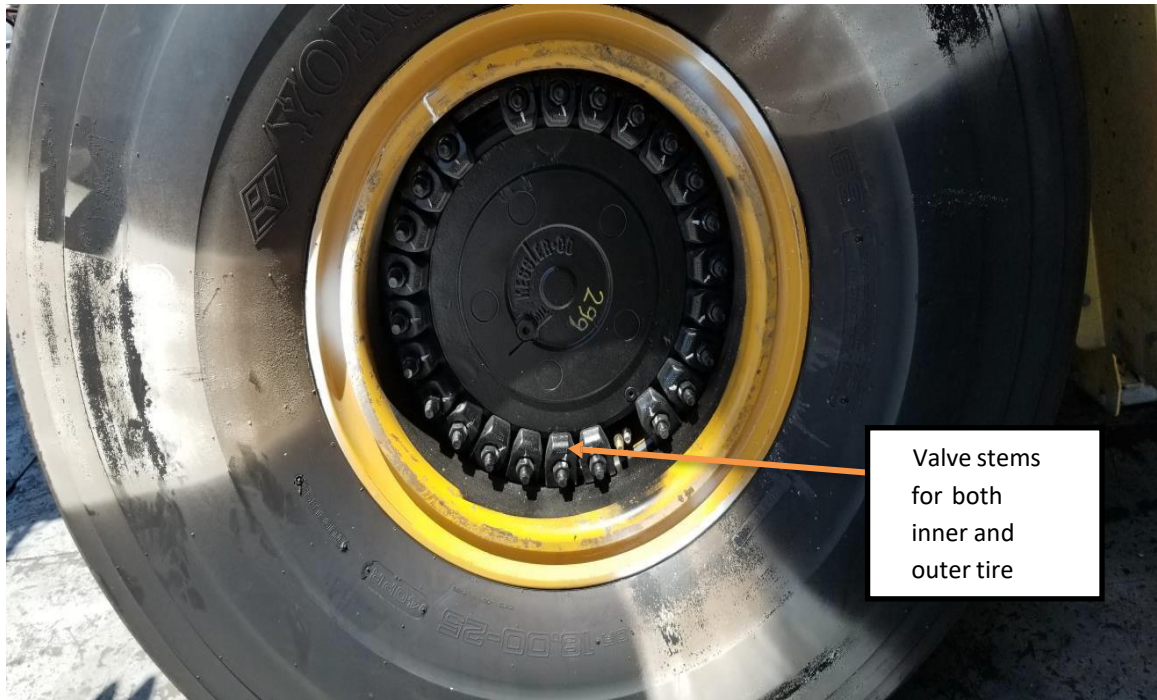
per square inch (psi). The dual wheels of the container handler are each fastened to the vehicle's axle with 28 lug nuts and clips (Exhibit 3).

**Exhibit 3.** A tire and wheel assembly similar to the one involved in the incident, including valve stems and 24-bolt pattern holding the wheel assembly together.

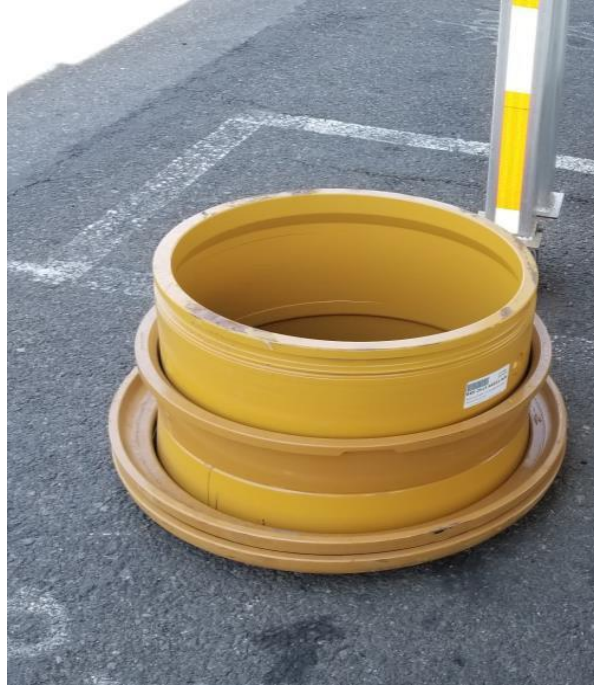
The wheel rim involved in the incident was a multi-piece wheel. A multi-piece wheel is a vehicle wheel consisting of two or more parts, one of which is a side or locking ring that holds the tire and other components on the rim wheel by interlocking the components when the tire is inflated. These multi-piece split-rim wheels consist of five components: a rim, two flanges, a taper or advance band, and a locking ring (Exhibits 4 & 5).

**Exhibit 5.** A multi-piece wheel similar to the one involved in the incident.

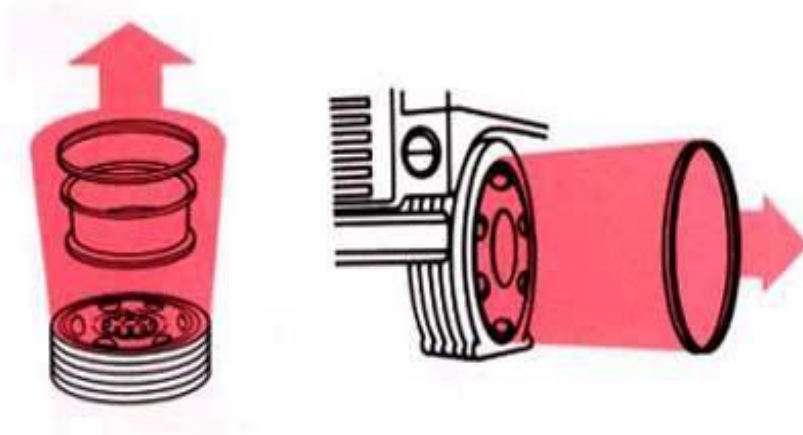
The principal hazard of multi-piece wheels is from pressurized air that, when suddenly released, can throw or shatter the tire or wheel assembly and strike the employee and co-workers. In a multi-piece rim wheel incident, the wheel components separate and are released with violent force (Exhibit 6). The risk of injury or death is greater with larger multi-piece wheel assemblies like the one in this incident. Often, inspections of wheel assemblies can reveal visible cracks that occur over time from metal fatigue.

**Exhibit 6.** Trajectory of multi-piece rim parts placed on the ground and mounted on a vehicle.

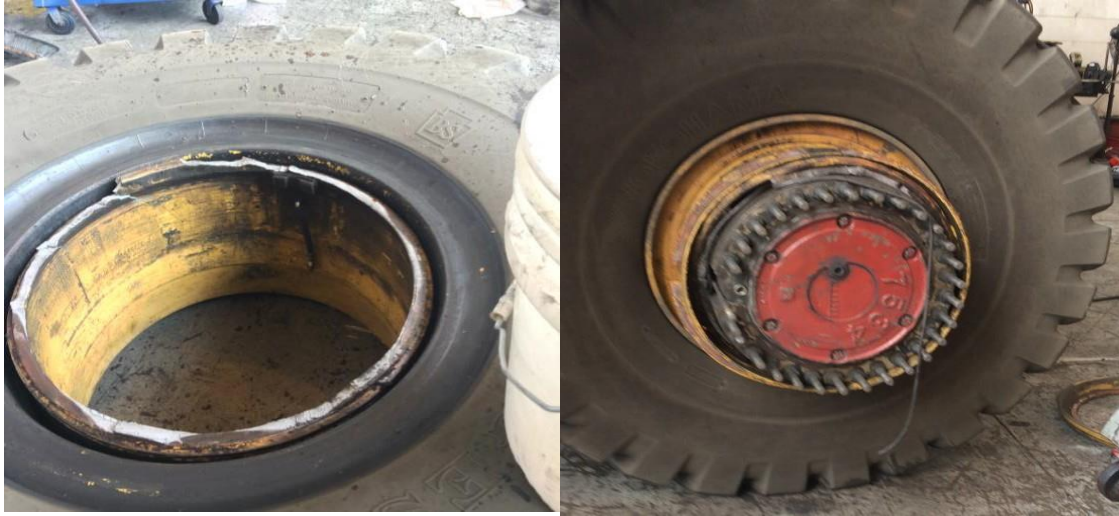
On the day of the incident, the victim and his co-worker picked up their job assignments from their supervisor. One of the assignments was to remove and replace the damaged outer dual wheel assembly from the container handler that was in the left bay of the mechanic shop. Cracks in the wheel assembly had been discovered during routine inspection which required the wheel assembly to be changed. There was another container handler in the right bay of the mechanic shop being worked on by another mechanic. At approximately 7:15 a.m., the victim and co-worker began removing the outer tire and wheel from the container handler. A hydraulic bottle jack was placed under the axle to raise the tires off the ground. The inner tire was deflated but the outer tire was not. The victim, standing in front of the outer tire and wheel assembly, started removing the tire lug nuts, one by one. As he was removing the last nut, an explosion occurred. The blast propelled the victim 20 feet into the air and into the other container handler in the right bay of the shop. The co-worker was also thrown backwards and landed on the concrete shop floor next to the other container handler. Portions of the wheel assembly were scattered throughout the shop (Exhibits 7 & 8).

**Exhibit 7 & 8.** The outer (left) and inner (right) tires on the container handler after the incident.
