FROM: California Fatality Assessment and Control Evaluation (CA/FACE) Program

SUBJECT: An Electrician Dies When He Is Crushed Between a Traveling Hoist and a Plating Tank

SUMMARY
California FACE Report #13CA004

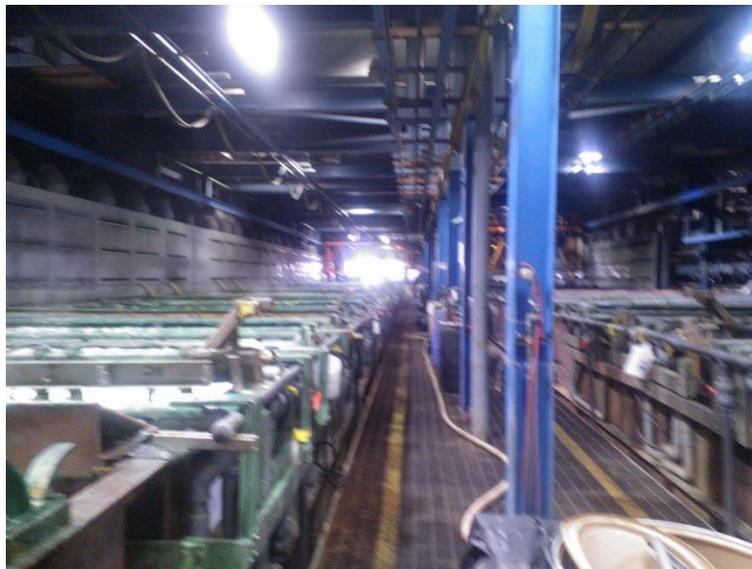
Exhibit 1. The chrome plating area of the business.

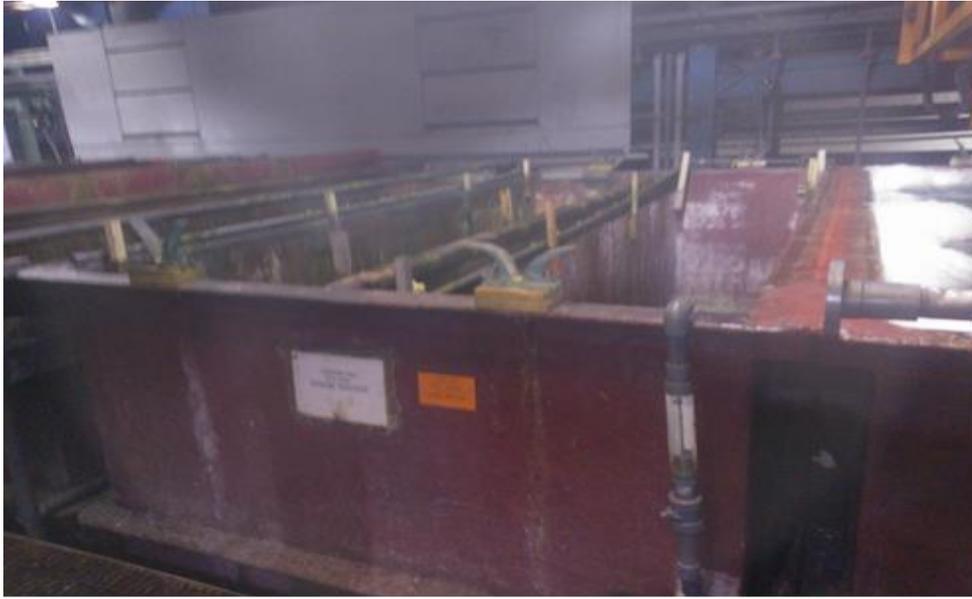
Exhibit 2. The chrome plating tanks.

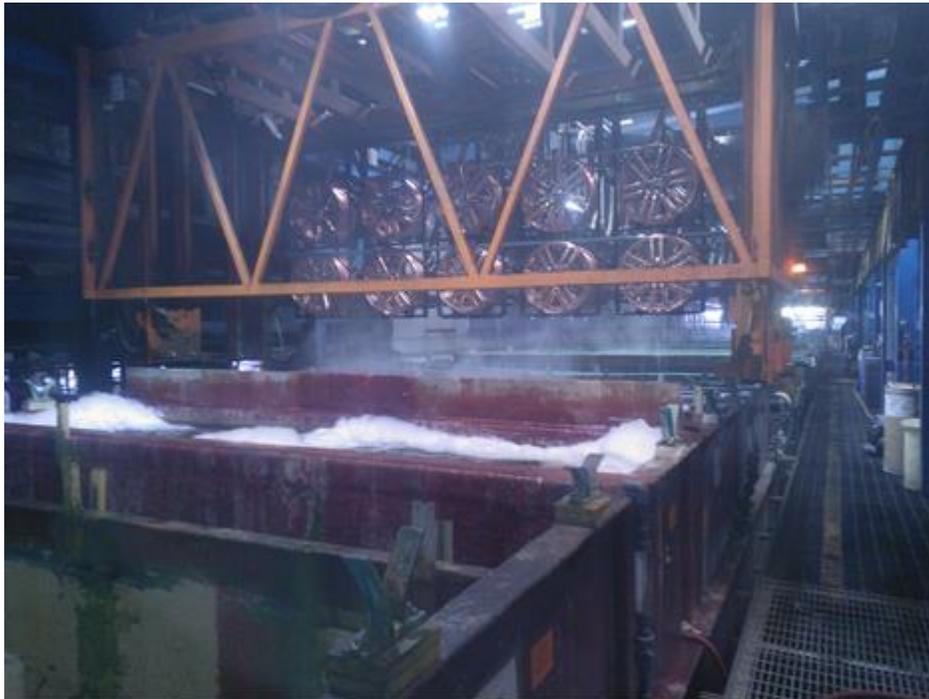
Based on information from co-workers, the victim most likely was leaning over the edge of the tank as the hoist passed by him. The safety sensor device on the hoist was not operational at the time of the incident. As the hoist automatically moved toward the victim, instead of shutting off when it made contact it continued on its path, pinning the victim between the tank and the pipes on the rim of the tank. It is not known why the victim did not get out of the way of the hoist. The hoist operator saw the victim pinned and immediately shut the hoist off and called his supervisor, who called 911. Other employees came to assist and removed the victim by cutting away the pipe. The paramedics transported the victim to the local hospital where he underwent emergency surgery. He was pronounced dead in the operating room.

Exhibit 3. The computer controlled hoist with an attached cage for the wheels.

Recommendation #1: Ensure that moving machinery is inoperable when employee access into a danger zone is required.

Discussion: In this incident, the victim entered a danger zone close to moving machinery while it was in operation. A danger zone is any place in or around a machine or piece of equipment where an employee may be struck or caught between moving parts, or caught between moving and stationary objects or parts of a machine. The danger zone at this scene is the area immediately adjacent to the tanks in the path of the hoist. In this incident, the hoist operator was supposed to stop hoist operation whenever he was notified by or observed an employee entering the danger zone. However, in this case the hoist operator did not observe the victim until he had been pinned by the hoist. Additional mechanisms could be installed that automatically stop hoist operation if an employee enters the danger zone. Such mechanisms could include gate interlocks, visual or auditory warning alarms, or sensing devices that would stop the hoist whenever an employee entered the danger zone. As an alternative, a lockout/tagout procedure would shut down the hoist operation whenever an employee was required to enter the danger zone of crane operation. Had these devices or procedures been in place, the hoist would

have been inoperable and the victim would not have been pinned while performing his work tasks.

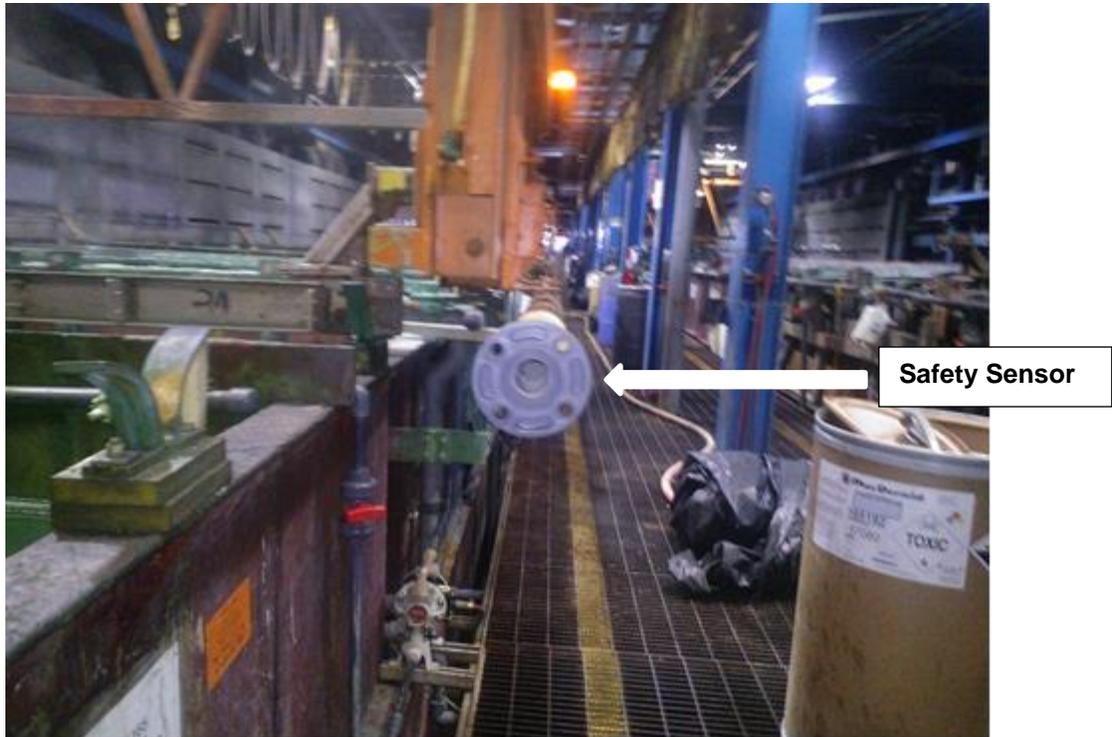
Discussion: In this incident, the hoist had a safety sensor device installed on its rail that was designed to stop the crane movement by activating an electrical sensor after contact with an object (such as an employee). Post-incident inspection of the sensor revealed that the local tank atmosphere resulted in sensor corrosion rendering the stop inoperable. Therefore, when the safety sensor device made contact with the victim the crane failed to stop operation.

The employer in this incident did not perform routine inspection and maintenance of the hoist safety sensor device. There was no documentation that the device was tested or deemed operable by company maintenance personnel. It is not known if the victim or hoist operator knew that the safety sensor device was inoperable. Had the safety sensor device on the hoist been inspected and repaired, the crane would have stopped when it made contact with the victim and prevented him from being pinned.

Exhibit 4. The safety sensor device designed to stop the hoist movement when contact is made.

Recommendation #2: Ensure that emergency safety devices are maintained in operating condition.

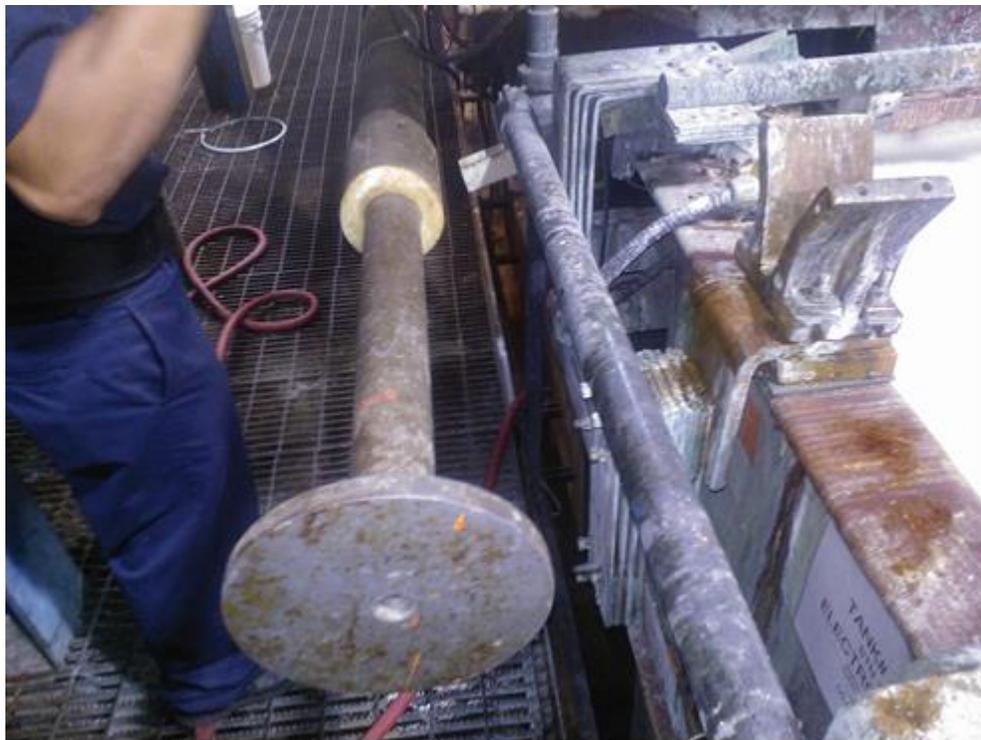
Exhibit 5. Close-up of the safety sensor device.

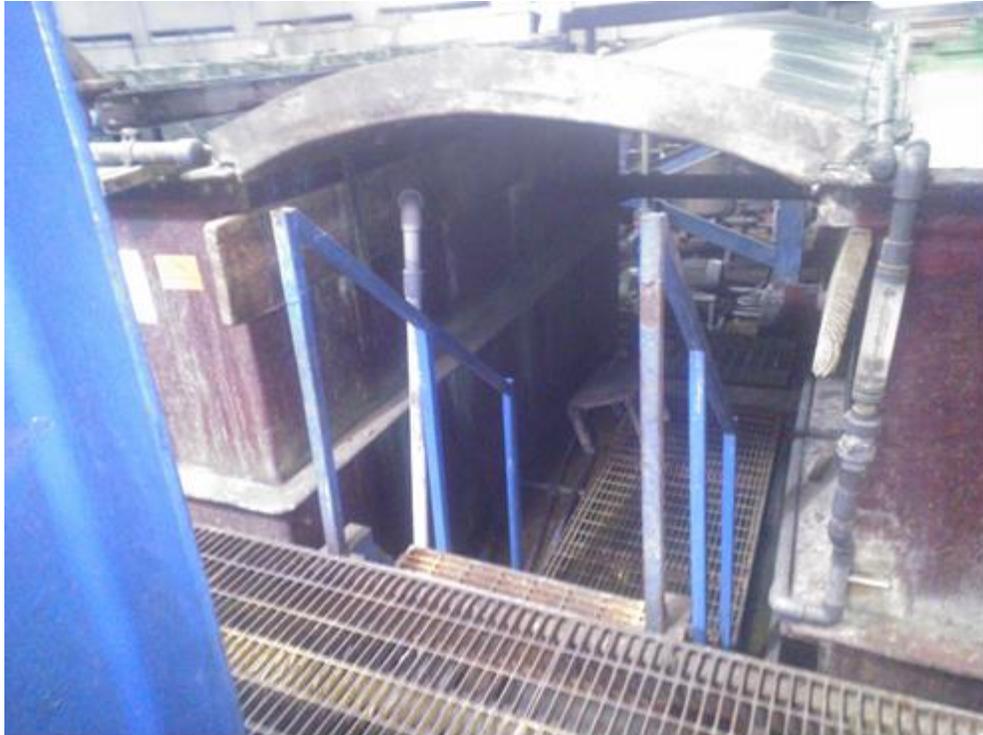
The victim's work shift was from 11:00 p.m. until 7:00 a.m. At the time of the incident, the hoist was programmed by the hoist operator to automatically chrome plate a stack of automotive wheels. At approximately 5:30 a.m., the victim entered the chrome plating area through an entrance in the middle of the tank area (Exhibit 6). The hoist operator stated that he was not aware that the victim was on the walkway between the tanks. There were no other workers present in the vicinity of the catwalk or who saw the victim enter the chrome plating area. According to the victim's supervisor, the victim may have been on the catwalk to check on the prior installation of a pump.

Exhibit 6. The entrance to the chrome plating tanks in the middle of the row.
