SUBJECT: A Welder Dies When the Scissor Lift He was Operating Tips Over

SUMMARY
California FACE Report #09CA008

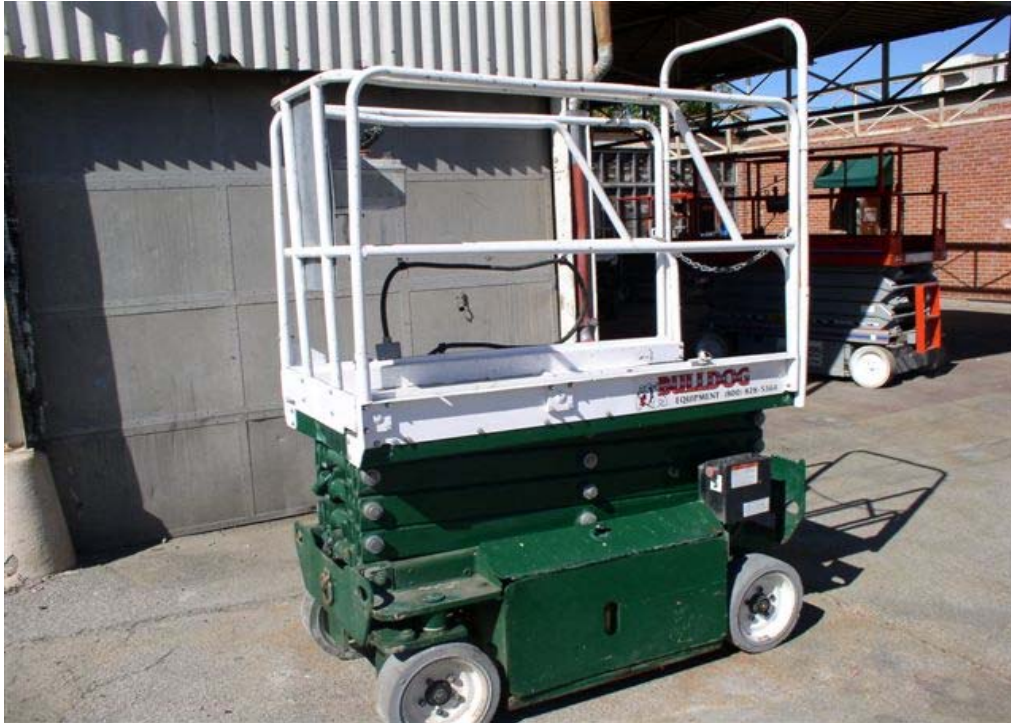
While in an elevated position, the victim moved the scissor lift forward to access his work. This movement caused the two front wheels of the scissor lift to roll into the depression of the pit. This momentum caused the entire scissor lift to topple forward onto the depression alongside the pit. The victim was ejected from the work platform headfirst, hit the opposite wall of the pit, and then fell to the pit floor. Several co-workers in the area ran to assist the victim. The paramedics and fire department responded within minutes and pronounced the victim dead at the scene.

Exhibit 1. The scissor lift involved in the incident.

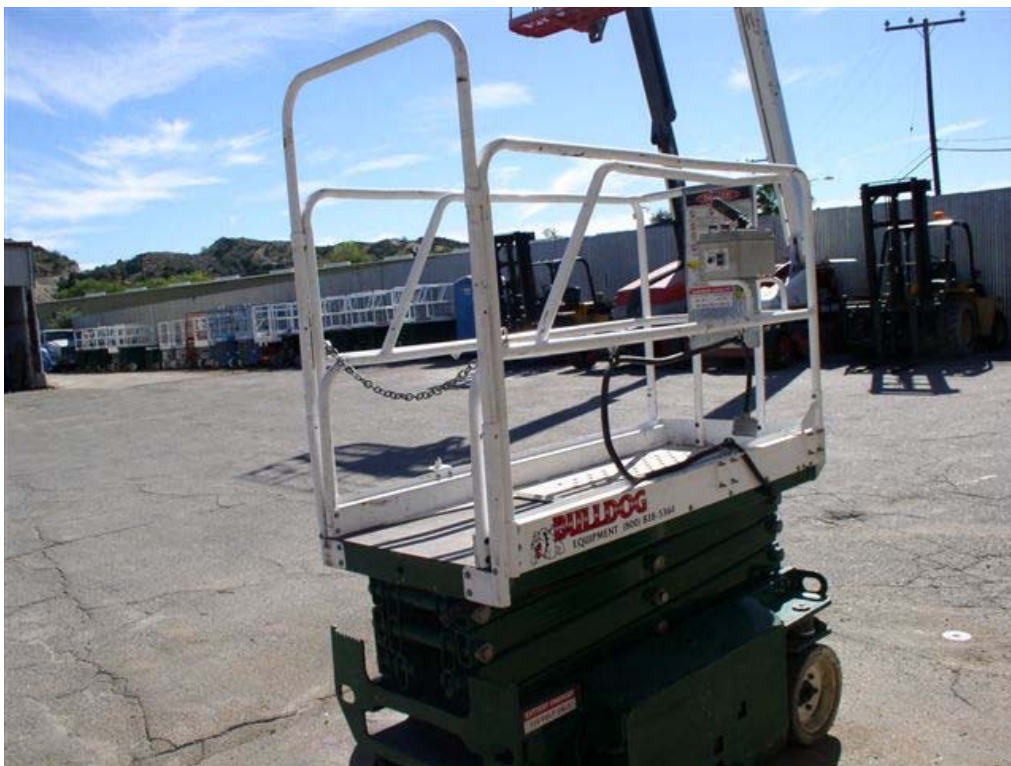
Exhibit 2. Alternate view of the scissor lift involved in the incident.

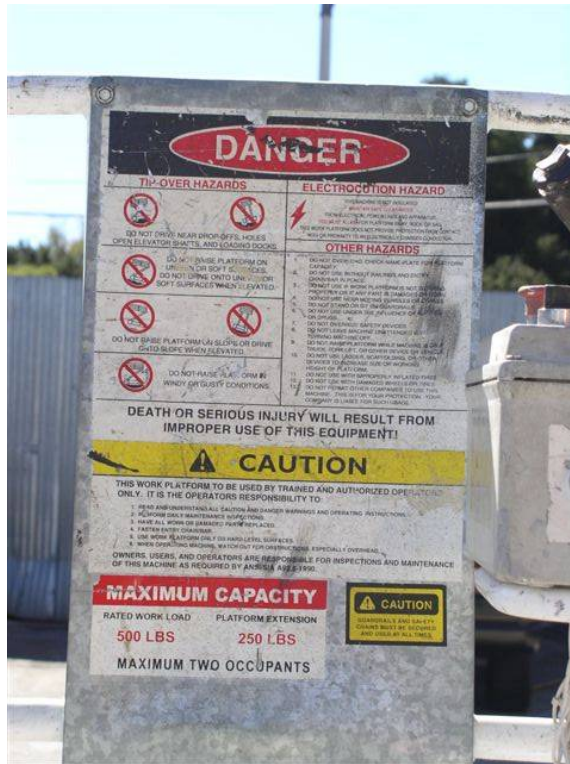
Exhibit 3. The placard attached to the scissor lift listing hazards associated with operation.

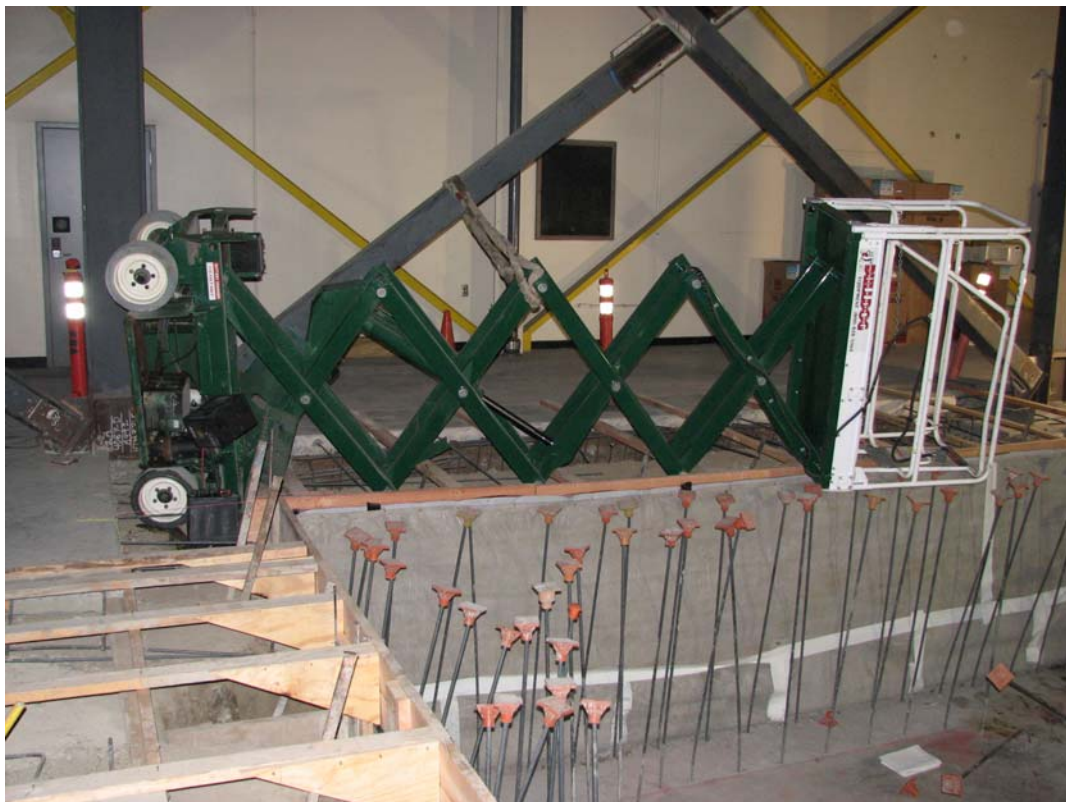
level and straight. According to the general contractor, the distance from the steel beam to the edge of the depression of the pit was approximately 30 inches. The only barrier between the scissor lift and the depression of the pit was an orange cone on the concrete floor.

Exhibit 4. The incident scene.

Recommendation #1: Employees perform a thorough hazard assessment and implement effective controls prior to using aerial lifts.

Recommendation #2: Employees not move scissor lifts forward or backwards while in the raised position.

Recommendation #3: Manufacturers should install safety interlocks that prohibit scissor lift travel while the platform is raised.
