**California Department of Public Health
Occupational Health Branch**

**FATALITY ASSESSMENT AND CONTROL EVALUATION
PROGRAM (CA/FACE)**

**A Solar Company Owner Dies When He Falls Through a Skylight
Case Report: 17CA005**

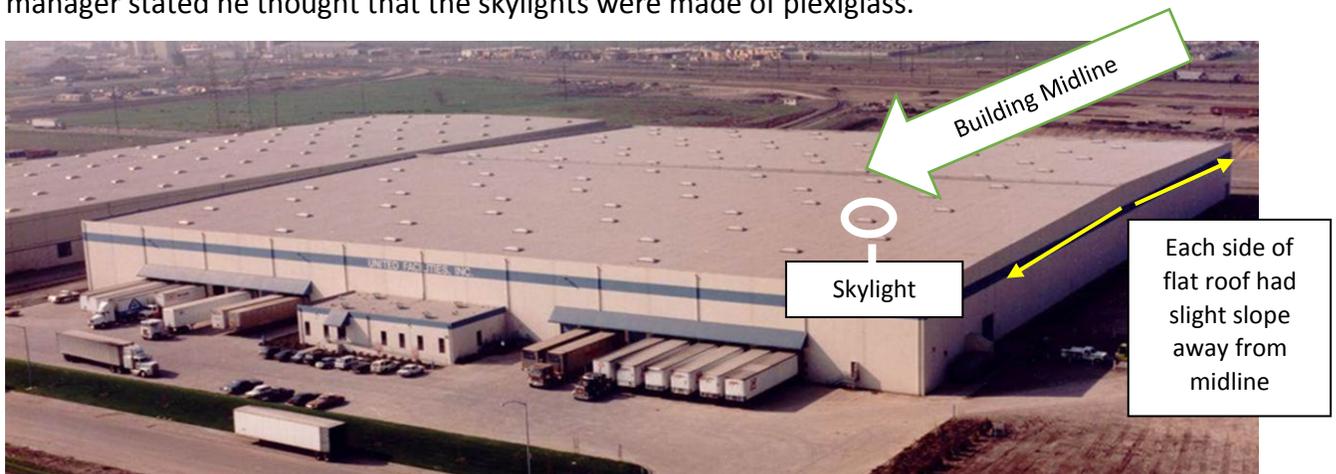
Exhibit 1 shows the aerial view of the warehouse. The flat roof of the warehouse contained 84 skylights, with 42 located on each side of the roof. The roof was divided by a midline with each side sloping away from the midline at a slight angle. The dimensions of the skylights were 4' x 8', with each skylight located 36 feet from an adjacent skylight. The roof was accessed by climbing a 40-foot ladder (Exhibit 2) inside the building. Exhibit 3 shows the entrance to the roof. The skylights that were being replaced were approximately 30 years old. A solar company manager stated he thought that the skylights were made of plexiglass.

Exhibit 1. The warehouse involved in the incident.

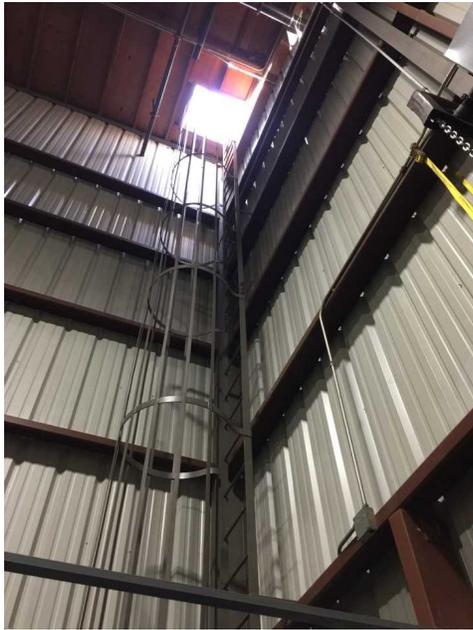
Exhibit 2. The 40-foot ladder used to access the roof.

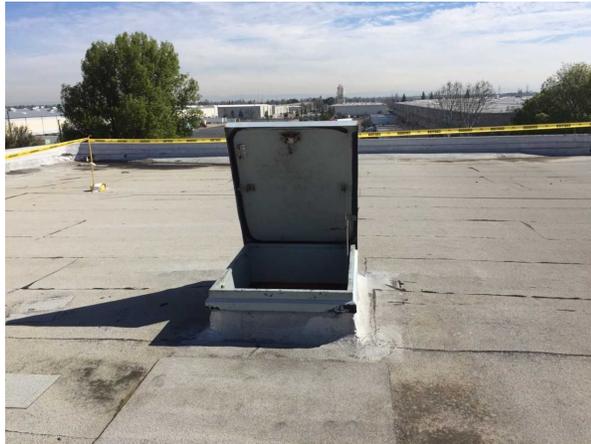
Exhibit 3. The entrance to the roof.

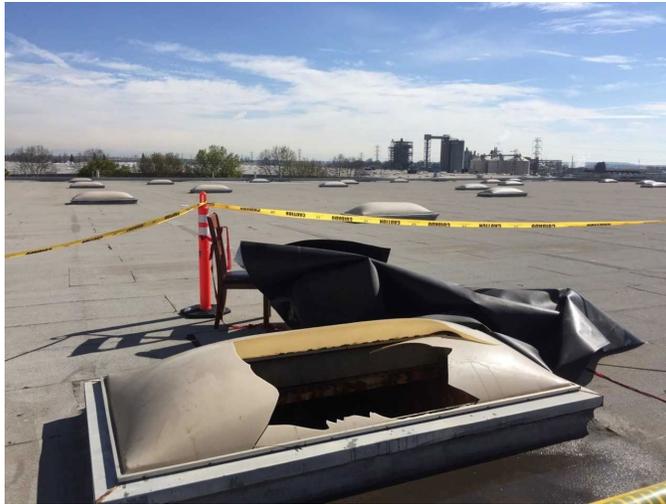
On the day of the incident, at approximately 12 p.m., the victim arrived at the facility and climbed up alone to the northeast side of the roof. At the time of the fall, eight workers were working on the other side of the roof, approximately 150 to 250 feet from where the incident occurred. The site foreman was on the ground organizing materials for the project. None of the employees who were working on the southeast side of the roof knew that the victim had gone up on the roof. Due to the small roof slope at the building midline (Exhibit 1), these employees did not have a clear view of the victim. Post incident, a tablet, a drone controller, and a drone, were found 1'4", 3', and 5', respectively, from the broken skylight. Therefore, the supervisors speculated that he went up on the roof to deploy the drone and perhaps to communicate New Year's greetings to his employees on the roof. Since the drone was found not fully assembled at the time of the victim's fall, the CA/FACE investigator hypothesized that the victim came within six feet of the skylight while preparing the drone and somehow lost his footing and fell through the skylight.

Exhibit 4. The skylight the victim fell through.

Recommendation: Ensure that employees performing work within six feet of a skylight use skylight screens, covers, guardrails, nets, or personal fall protection systems—even for short-duration tasks such as periodic inspections or maintenance.

Companies with employees who work near skylights should have either a passive or active fall prevention safety system in place, regardless of roof height (Cal/OSHA Title 8, Section 3212 for General Industry and Sections 1670, 1671, 1671.1 for Construction Industry). Examples of passive systems include guardrails, nets, screens, and covers. If it is not feasible for short-duration tasks (periodic inspections, maintenance, and repairs) to install a passive safety system, an active safety system such as a Fall Arrest System (body harness, shock absorbing lanyard, and anchorage points supporting at least 5,000 pounds) or a Fall Restraint System (body harness or belt, anchorage points supporting at least 4 times the intended load) should be worn by the worker. All roofs require periodic maintenance or repairs, especially roofs with skylights and solar panels. If a fall prevention system had been installed, or if the victim had been wearing personal fall protection, his death could have been prevented.

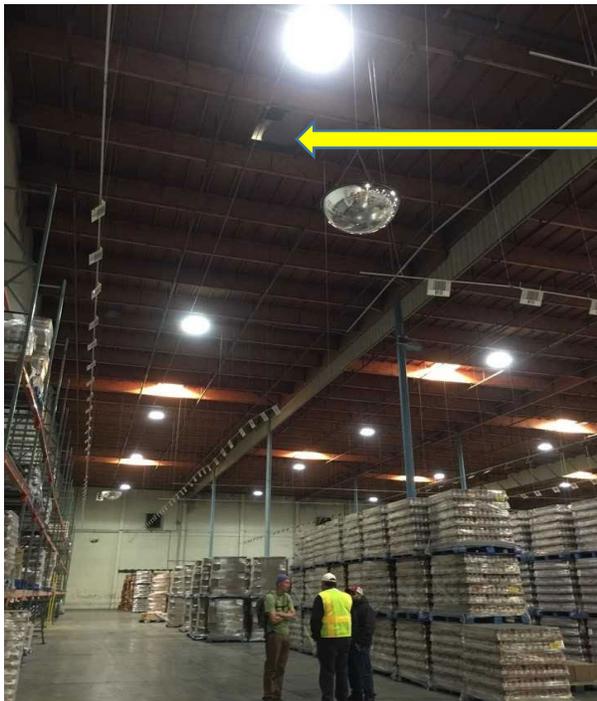
No one at the company was aware that the victim had fallen until a warehouse worker found him unconscious on the floor, approximately 15 minutes after he fell. The warehouse worker immediately called 911. Emergency services arrived in less than ten minutes. The victim was transferred to a local hospital where he died later that day. Exhibit 4 shows the broken skylight. Exhibits 5 and 6 show the underside of the broken skylight from inside the warehouse.

Exhibit 5. Broken skylight from inside the warehouse.

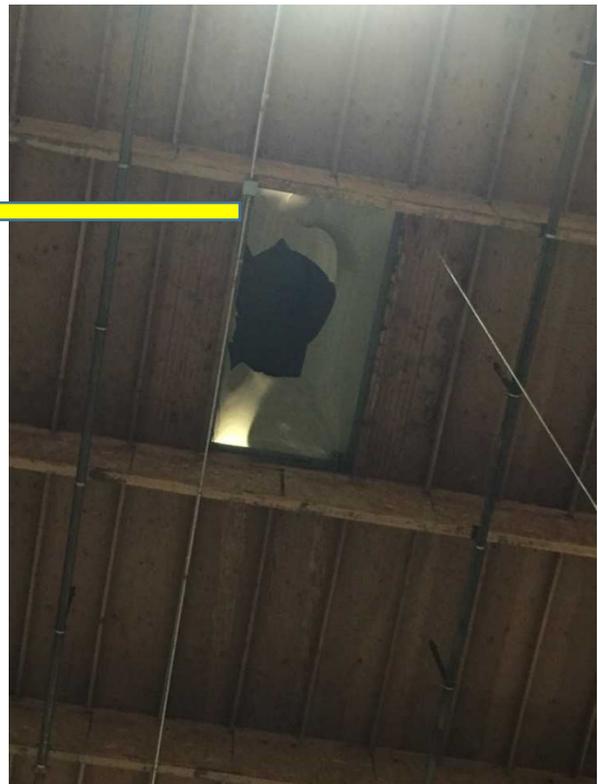
Exhibit 6. Close-up of broken skylight from inside the warehouse.

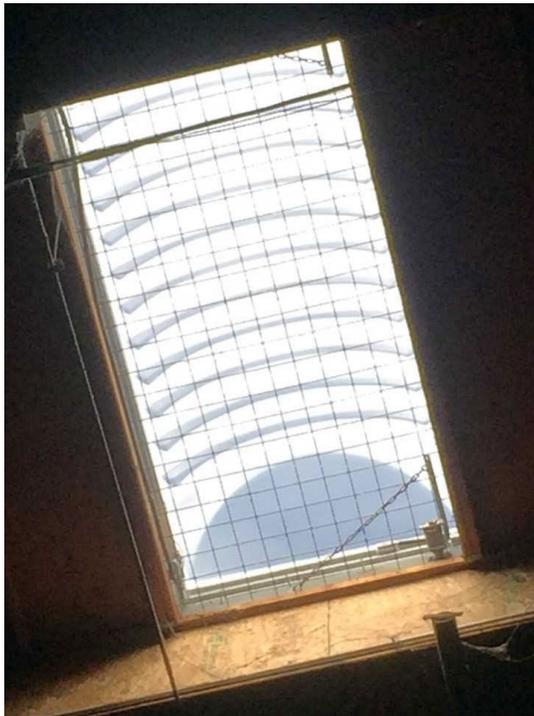
Exhibit 7: Skylight with screen, installed after the fatality.
