**FATALITY ASSESSMENT AND CONTROL EVALUATION PROGRAM  
(CA/FACE)**

A heavy equipment operator dies when he was struck by an excavator  
bucket that detached from a quick coupler

Case Report: 20CA001

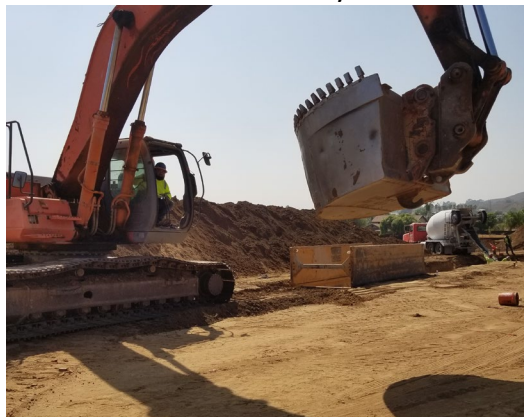
The machine involved in this incident was a Hitachi hydraulic excavator (Exhibit 1). Attached to

Exhibit 1. The excavator involved in the incident.

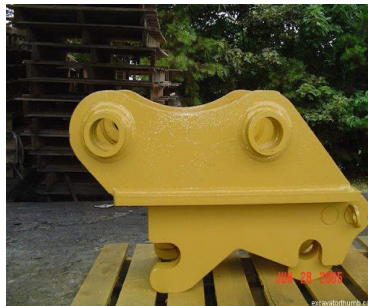
the end of the boom was a hydraulic device called a quick coupler. Quick couplers are made by various manufacturers and have several designs. They are installed at the outer end of booms by the pins that would normally be the mountings for the bucket or attachment (Exhibit 2). They facilitate the rapid exchange of working tools or buckets. The quick coupler involved in this incident was fully automatic. The distributor of the quick coupler was Steel Unlimited Inc. The coupler was hydraulically connected to a Geith hydraulic control panel in the excavator operator's cab (Exhibit 3). The control panel is designed to hydraulically lock the bucket to the quick coupler, and has an alarm to warn the operator when the mechanism malfunctions. The excavator operator typically confirms proper attachment of the bucket by raising the boom and testing the operation of the bucket prior to use.

Exhibit 2. A quick coupler similar to the one involved in this incident.

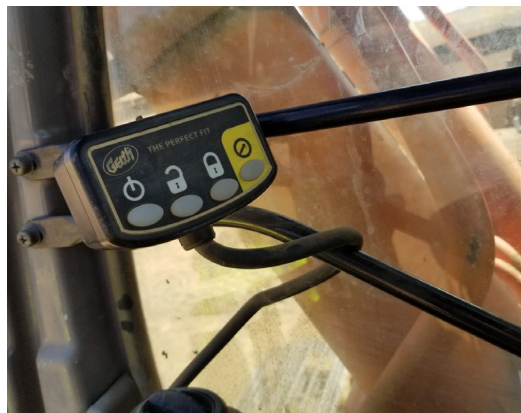
Exhibit 3. The automatic hydraulic quick coupler control panel.

It is not known why the victim stopped the excavator boom and exited the cab. It is possible that the quick coupler locking mechanism did not fully engage and the victim was alerted by an

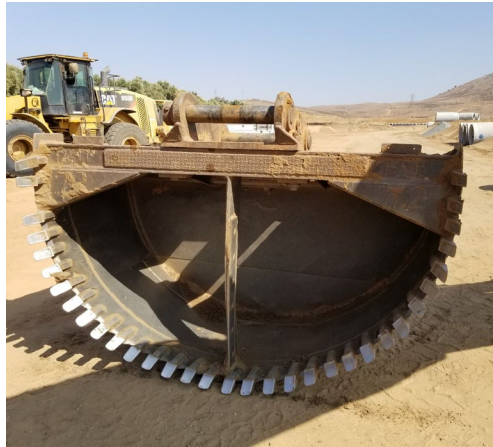
alarm on the control panel. The victim may have exited the cab to check on the bucket. The supervisor witnessed the victim approach the elevated bucket from underneath, and then the bucket detached, striking the victim (Exhibit 4). The decedent fell onto a small dirt berm at the edge of the trench. 911 was immediately called and the supervisor performed cardiopulmonary resuscitation (CPR) until emergency services arrived. The fire department provided advanced cardiac life support (ACLS) measures and transported the victim to the hospital where he was pronounced dead by the attending physician.

Exhibit 4. The bucket that disconnected from the coupling.

Discussion: In this incident, the victim left the cab while the boom and bucket were still elevated. If operators become aware that the bucket is not operating properly, they should always lower the bucket to the ground before inspecting. If the bucket had been lowered to the ground, it would not have disconnected and fallen on the victim.

Discussion: In this incident, the victim exited the cab and walked underneath the elevated bucket. All heavy equipment poses serious—even potentially fatal—risks to operators and others working in the vicinity. The relatively quick and far-reaching motion of the boom and bucket on an excavator is a particular source of danger. Manufacturers of excavators advise that no one should

walk below an elevated load or work within the boom swing radius during operation. If the victim had not walked under the elevated load, he would not have been struck by the bucket.

### **Recommendation #1: Always lower the bucket to the ground before exiting the cab.**

### **Recommendation #2: Never walk/traverse beneath an excavator boom swing radius or elevated load.**

**Recommendation #3: Train hydraulic excavator operators in the proper procedures for engaging excavation attachments and incorporate these procedures into the company's safety and health program.**

Discussion: In this incident, the victim had received OJT training on how to operate the excavator. There was no documentation that he received specific instruction on the operation of quick couplers. If the victim had received increased training on excavator operations, he may have had greater knowledge about how quick couplers function and the the proper safety procedures to follow. With additional training, the victim may have lowered the boom to the ground, thereby preventing this incident.
