**SUBJECT:** A Tree Trimmer is Electrocuted When a Tree Branch Falls onto Energized Electric Power Lines

**SUMMARY**  
**California FACE Report #11CA003**

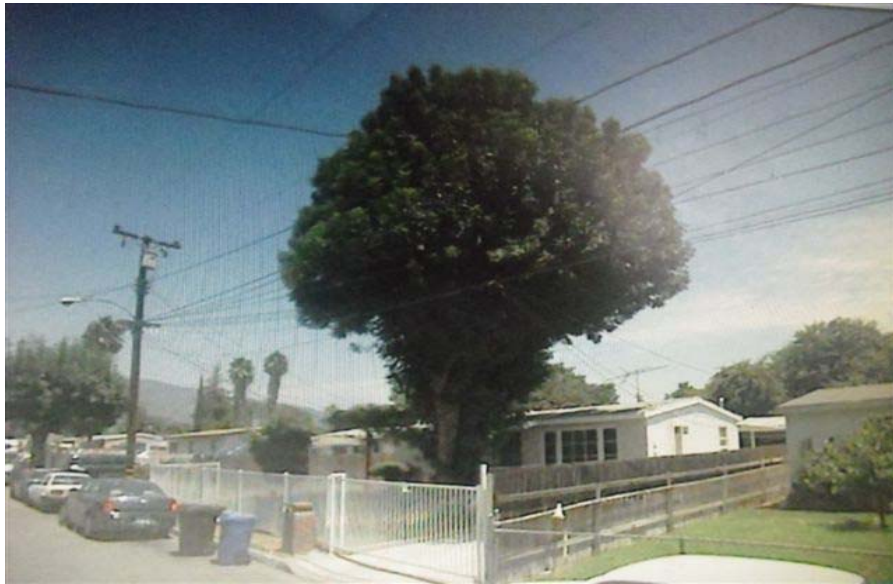
the tree with his brother and sons. The tree was located approximately eight feet from the home and was adjacent to the 16,000 volt power distribution lines that supplied electricity to the homes on that street. The victim put on a fall protection harness and a slip line, a climbing rope, and drop line along with climbing spurs on his legs. He then climbed the tree, removed all slack in his climbing rope, pulled up a chain saw, and began trimming the branches. As the branches fell to the ground, the victim's brother and sons dragged them to a trailer attached to a pickup truck parked in front of the house. Many neighbors gathered across the street to watch the work in progress.

At approximately 3:00 p.m., the victim was about 35 feet up in the tree and cut a branch that fell onto the energized electric power line. The cut branch had not completely detached from the tree and, when it made contact with the energized power line, the electric current traveled through the branch, back to the tree, and then to the victim through his climbing spurs, climbing rope, or flip line. According to the victim's brother, the victim dropped the chain saw to the ground and fell backwards in his harness as his legs straddled a larger branch of the tree.

**Exhibit 2. The tree and electrical utility lines.**

**Recommendation #1: The electric utility company is notified whenever tree trimming is closer than ten feet to energized high-voltage electrical lines.**

energized high-voltage lines. The lines should be de-energized or covered prior to the work being performed, and then re-energized or uncovered after the work is complete. Had the electric utility company been contacted and informed of the tree trimming operation, the line would have been de-energized and the victim would not have been electrocuted.

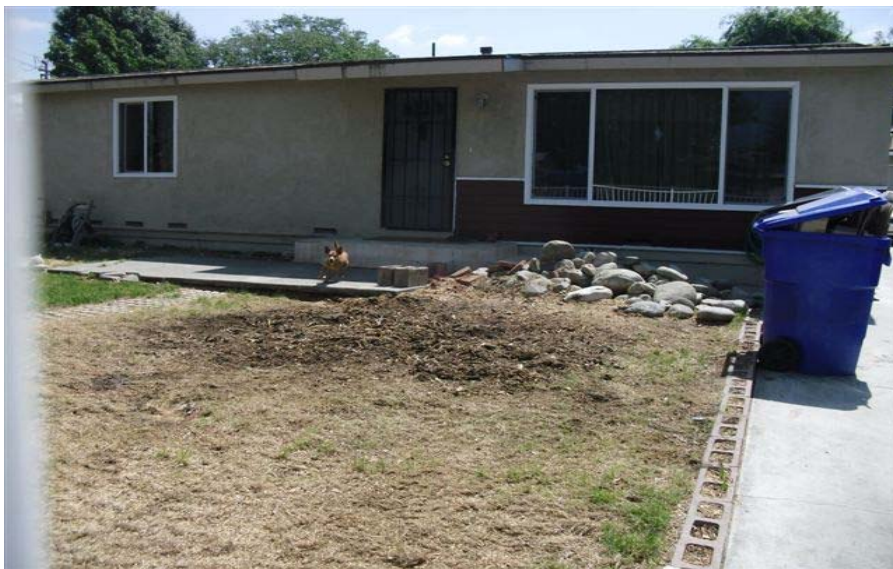
**Exhibit 3. The front yard after the tree was removed.**
