SUBJECT: A Maintenance Worker Dies from Exposure to Dichloromethane (Methylene Chloride) While Stripping the Floor of a Baptismal Font in a Church

SUMMARY
California FACE Report #12CA002

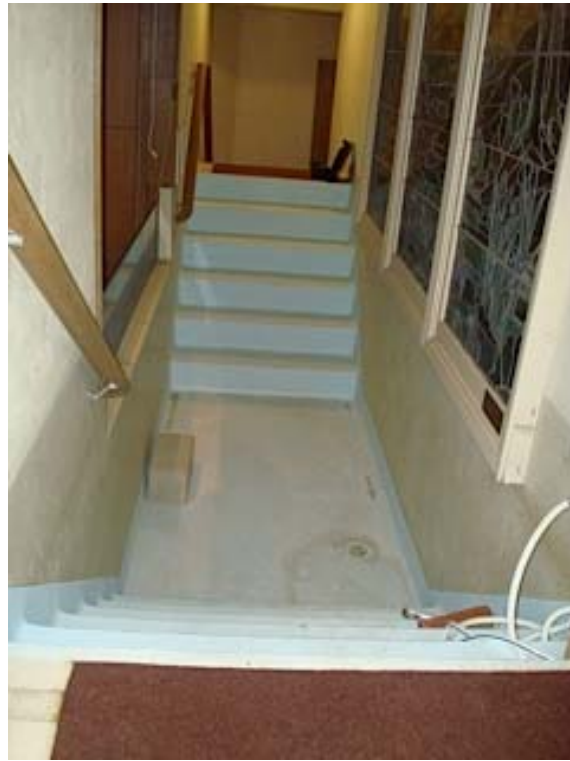
The incident scene was the baptismal font within the main worship area of the church. The baptismal font for this church was a built-in fixture of the church that resembles a large walk-in bathtub. The baptismal font was located within a narrow room (41' long x 4' wide x 12' high) with doors at each end and a large window facing the congregation to allow the worshipers to witness baptisms (see Exhibit 1). The baptismal font was

eight feet long by four feet wide. The font was made out of a common resin that had been painted. The paint coating was peeling and needed to be stripped about every 3 to 5 years.

Exhibit 1. The floor and stairs of the baptismal font.

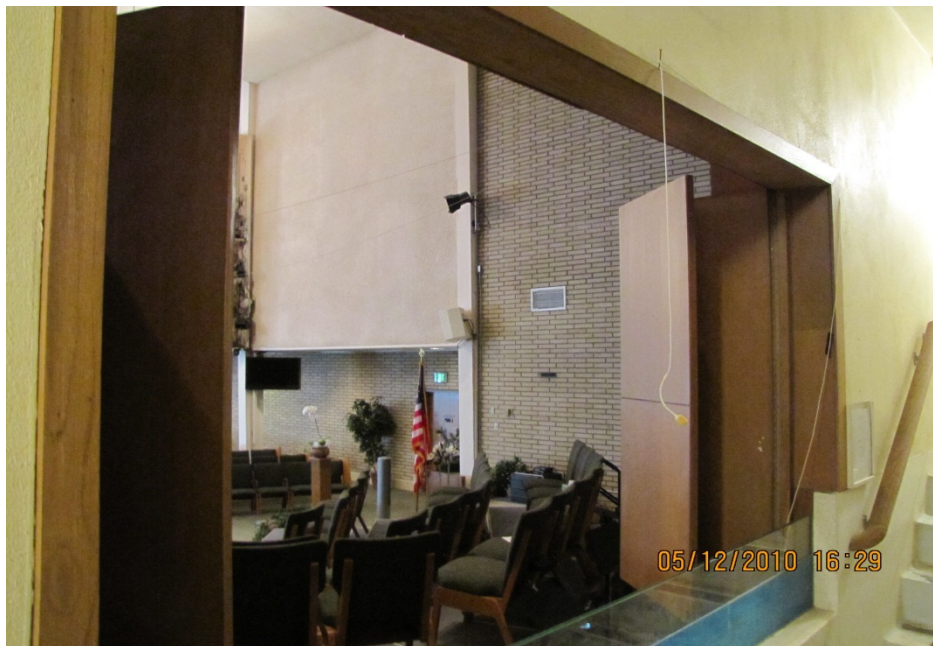
Exhibit 2. The window within the baptismal font that opens to the church worship area.

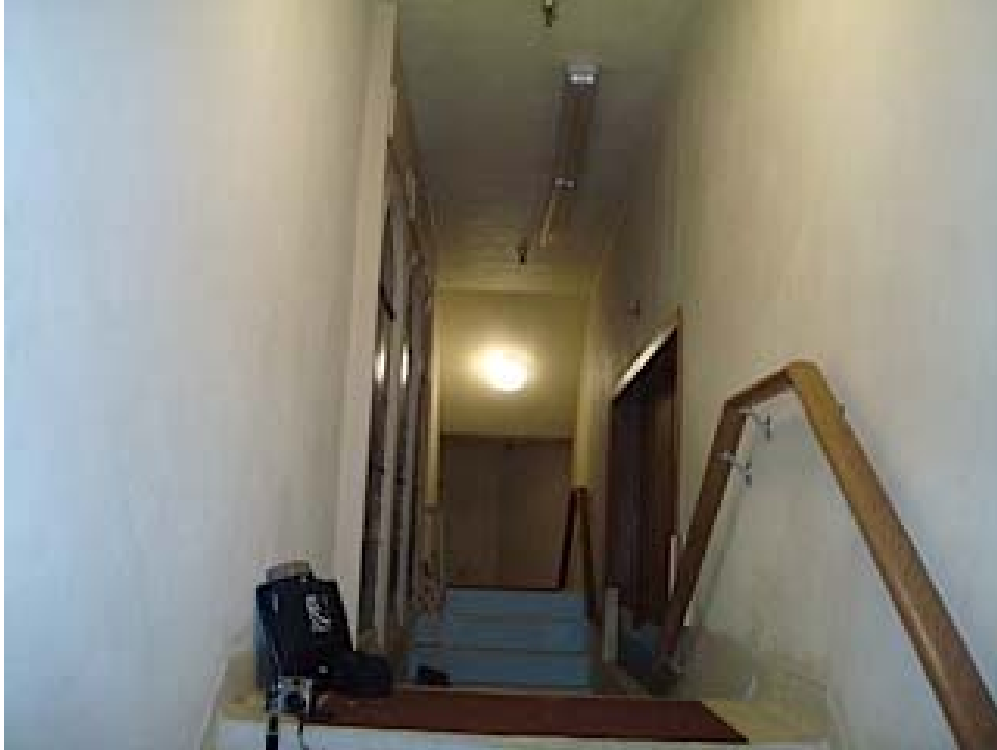
Exhibit 3. The narrow hallway leading to the baptismal font.

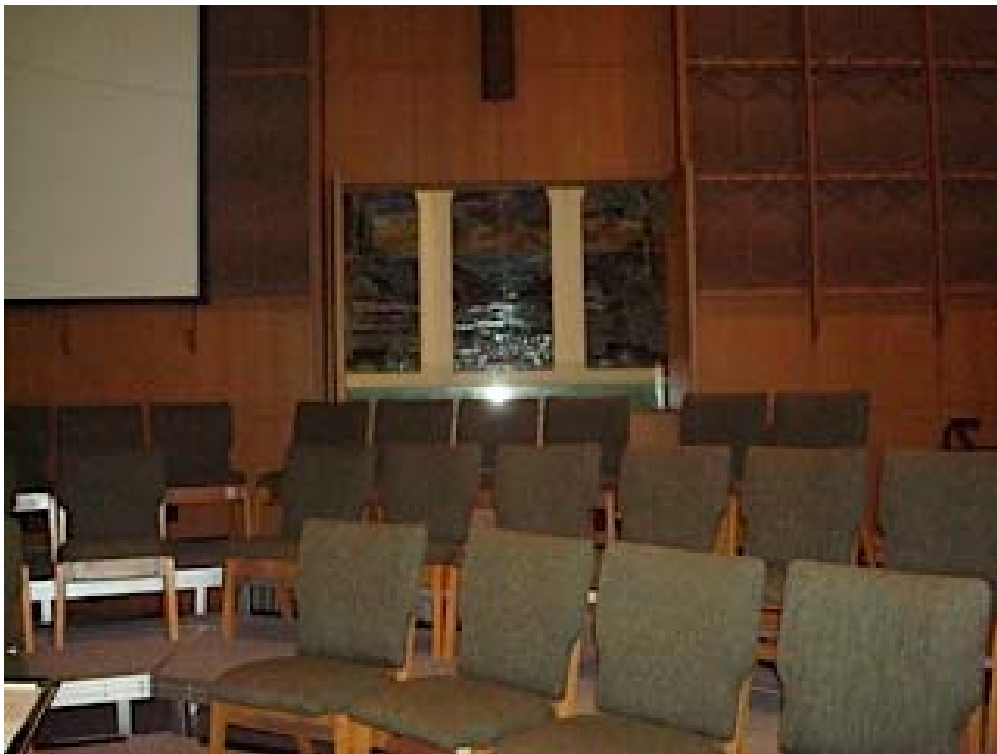
Exhibit 4. A view of the baptismal font from inside the worship area.
