**FATALITY ASSESSMENT AND CONTROL EVALUATION PROGRAM
(CA/FACE)**

A pipefitter, working in a trench, died when he was struck by an excavator bucket that detached from a quick coupler

Case Report: 20CA002

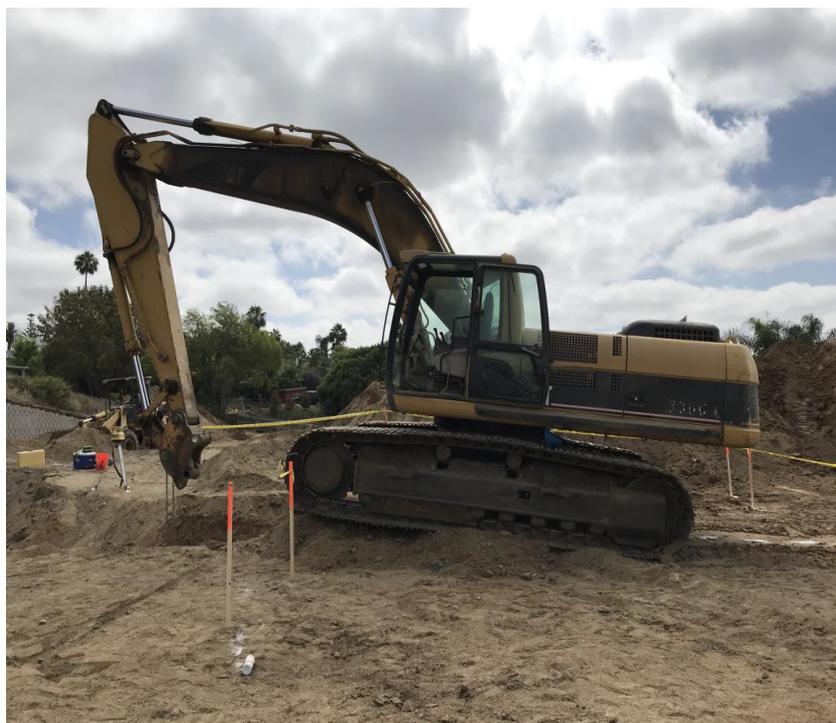
Exhibit 1. The excavator involved in this incident.

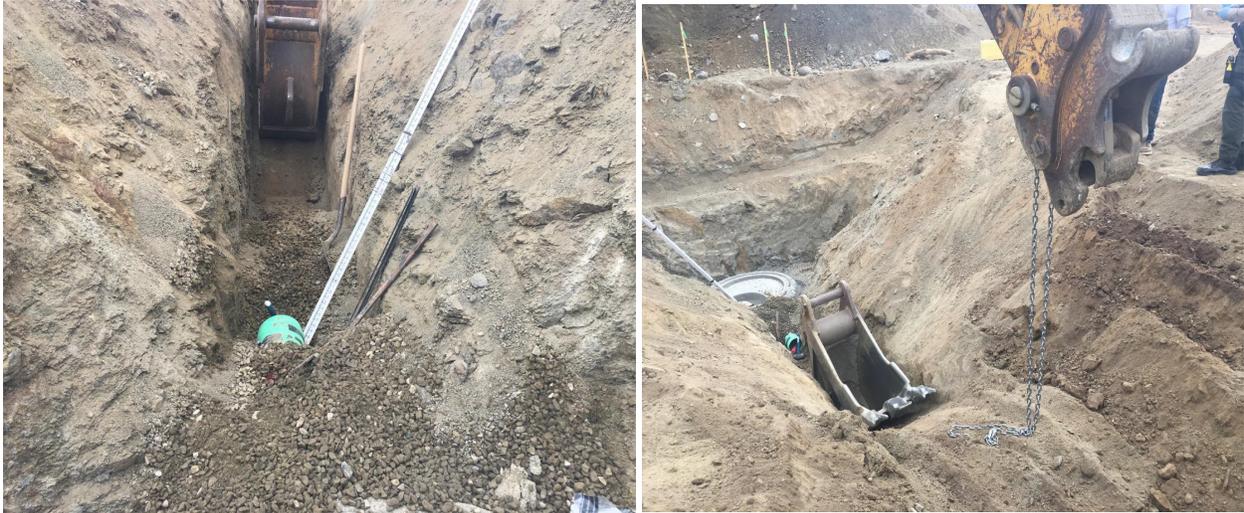
At the time of the incident, the excavator operator was digging an additional trench next to existing underground sewer pipes. The new trench was going to accommodate more pipes that would be tied into the current sewer system (Exhibits 2 & 3). The depth of the trench was approximately nine feet. The deepest four feet were straight-sloped and wide enough to accommodate the new polyvinyl chloride (PVC) sewer pipes (Exhibit 4). The victim was likely in the trench acting as a spotter to signal to the operator where to move the bucket so that it would not damage existing pipe already in the trench.

Exhibit 2 and 3. Alternate views of the trench.

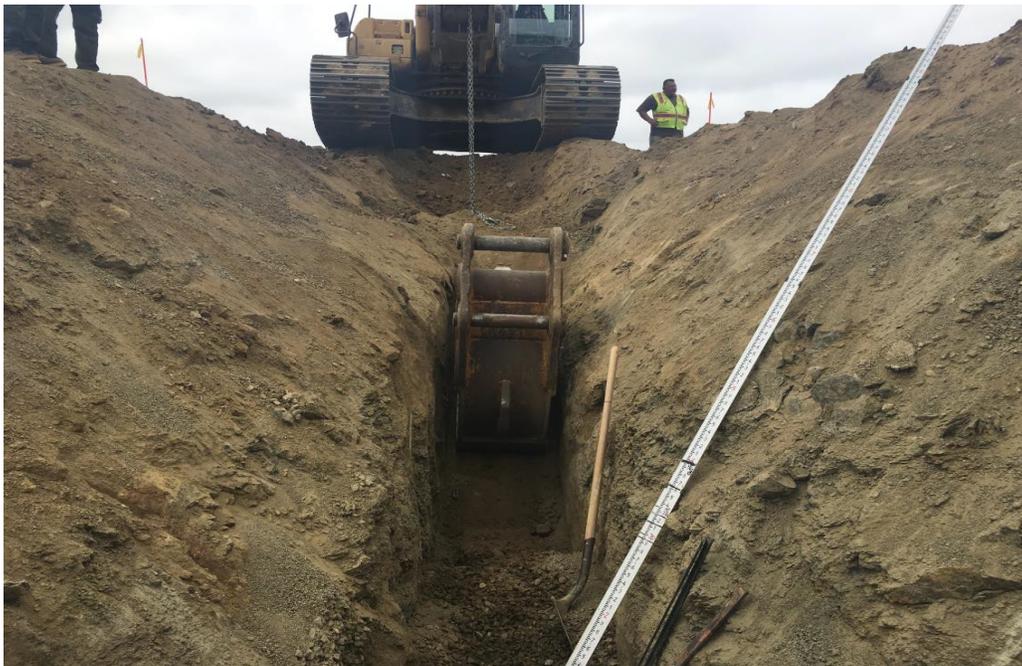
Exhibit 4. Slope and depth of the trench.

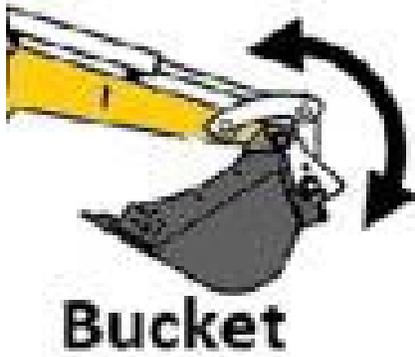
After digging a portion of the trench, the operator began curling the bucket (Exhibit 5) when it suddenly detached from the quick coupler (Exhibit 6) and struck the victim. The operator called 911 and used a chain attached to the excavator boom to remove the bucket from the victim. Emergency response personnel arrived on scene and removed the victim from the trench. Despite life saving measures, the victim was pronounced dead at the scene.

Exhibit 5. Bucket being curled into the end of a boom.

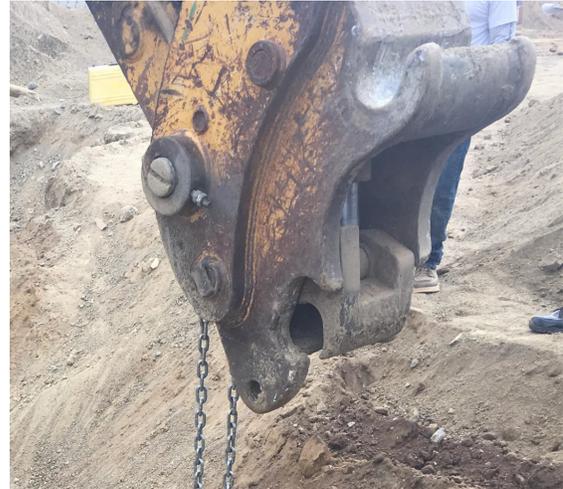
Exhibit 6. The quick coupler attached to the end of the boom.

Discussion: The bucket detached from the quick coupler during operation, suggesting that there was an equipment malfunction. Although it is unknown why the bucket detached, the operator stated that the quick coupler had recently been repaired. It is unknown if the operator performed an inspection of the quick coupler prior to use. Employers using hydraulic excavators with quick couplers can prevent release of attachments by:

Recommendation #1: Maintain and inspect quick couplers to prevent malfunctions that may cause an unintended release of the excavator's bucket.

- Inspecting all quick couplers to determine if they are subject to unexpected release hazards.
- Using newer models of quick couplers that have been specifically designed to prevent the unintended release of attachments.

- Following the manufacturer's recommendations for maintenance and inspection of quick couplers.
- Training workers in the proper use of quick couplers, including making visual inspections, proper procedures for engaging attachments, and methods for testing connections.
- Requiring workers to use proper procedures for engaging excavator attachments and incorporating the procedures into the company's safety and health program.

It is possible that proper maintenance and inspection may have identified a mechanical problem with the quick coupler, thereby preventing detachment of the bucket.
