FROM: California Fatality Assessment and Control Evaluation (CA/FACE) Program

SUBJECT: Construction Laborer Dies After Being Crushed Under a Concrete Patio Foundation

SUMMARY
California FACE Report #09CA002

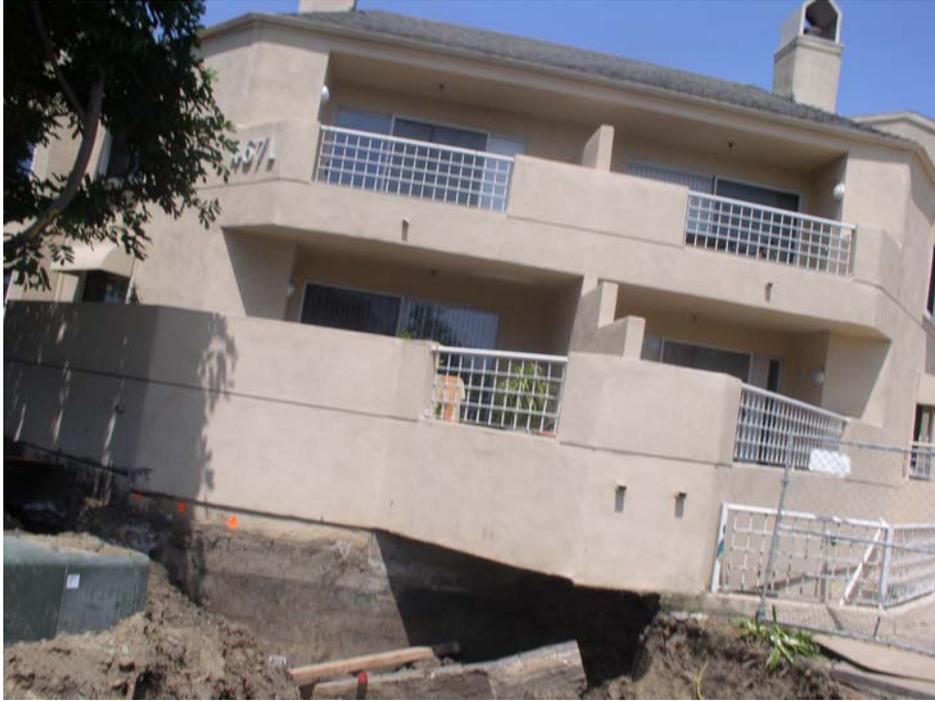
Exhibit #2. The two apartment patios affected by the excavation.

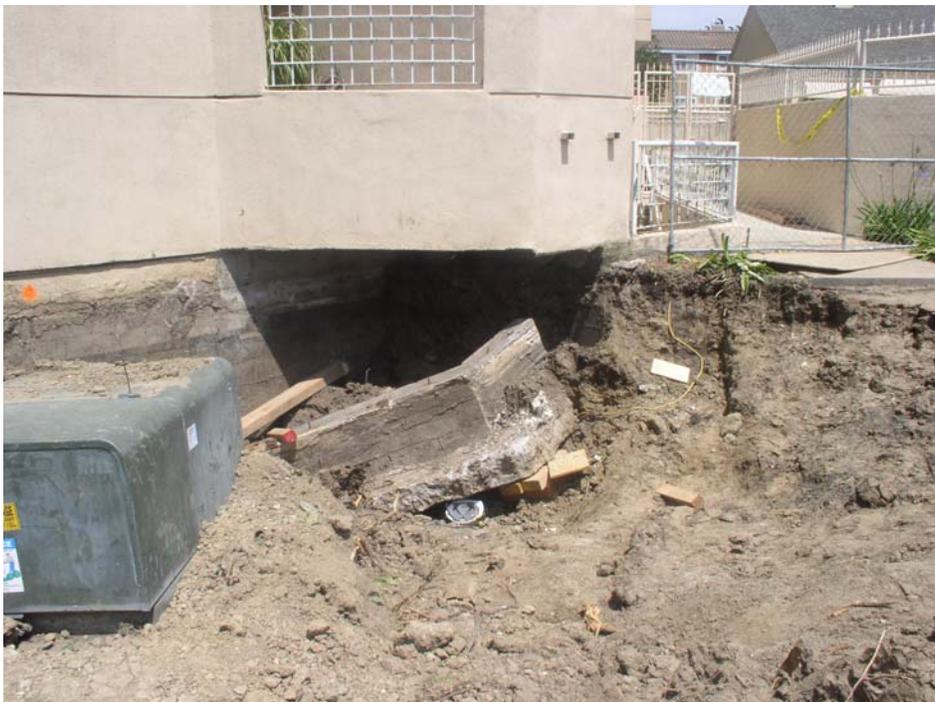
On the day of the incident, the victim and his co-worker were excavating soil around the perimeter of an apartment building to expose the foundation for waterproofing. The northeast corner of the building had a patio deck with a foundation measuring approximately three feet by five feet. The patio foundation was separate from the apartment building foundation. The victim and his co-worker had been instructed that morning by their supervisor to continue excavating the soil around the perimeter of the building foundation. At approximately 2:30 p.m., the victim was on his knees under the patio concrete deck using an electric chisel to break away compacted soil against the patio foundation. His co-worker was removing the loosened soil with a shovel. The depth of the excavation at this location was approximately six feet, and it was not shored or sloped. As the co-worker stepped back from the excavation, he witnessed the patio concrete fall on the victim and trap him underneath. A tenant in the building who heard the incident called emergency response. The area was excavated in order to reach the victim. The victim was declared dead at the incident scene.

Exhibit #3. The incident scene.

Recommendation #1: Protective systems are in place before employees place themselves under any object that has been undermined as part of an excavation.

Discussion: In this incident, the victim was removing soil under a heavy object (patio deck) that was not supported to prevent collapse after it was undermined. When an

excavation undermines the stability of a heavy structure, support systems such as bracing or underpinning should be used to ensure the stability of that structure to prevent collapse. These safety devices should be at the work site and placed under the structure when undermining occurs. Had such bracing or underpinning been in place at the time of the foundation excavation, the concrete deck would not have collapsed and pinned the victim underneath. Although it was not a factor in the victims death, trenches greater than 5 feet deep should be shored, benched or sloped.

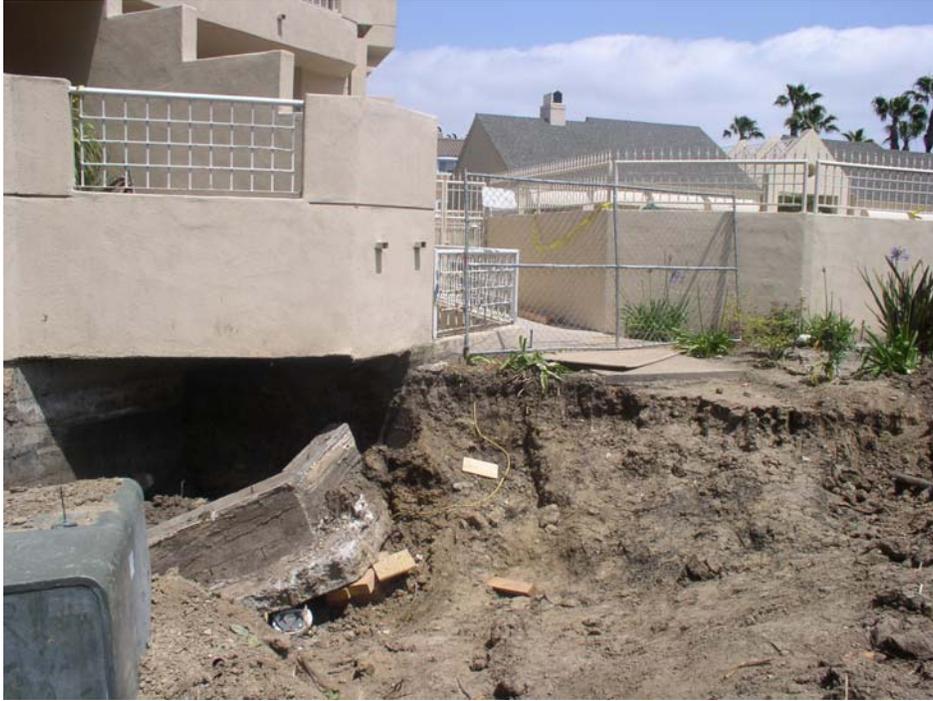
Exhibit #4. An alternate view of the incident scene.

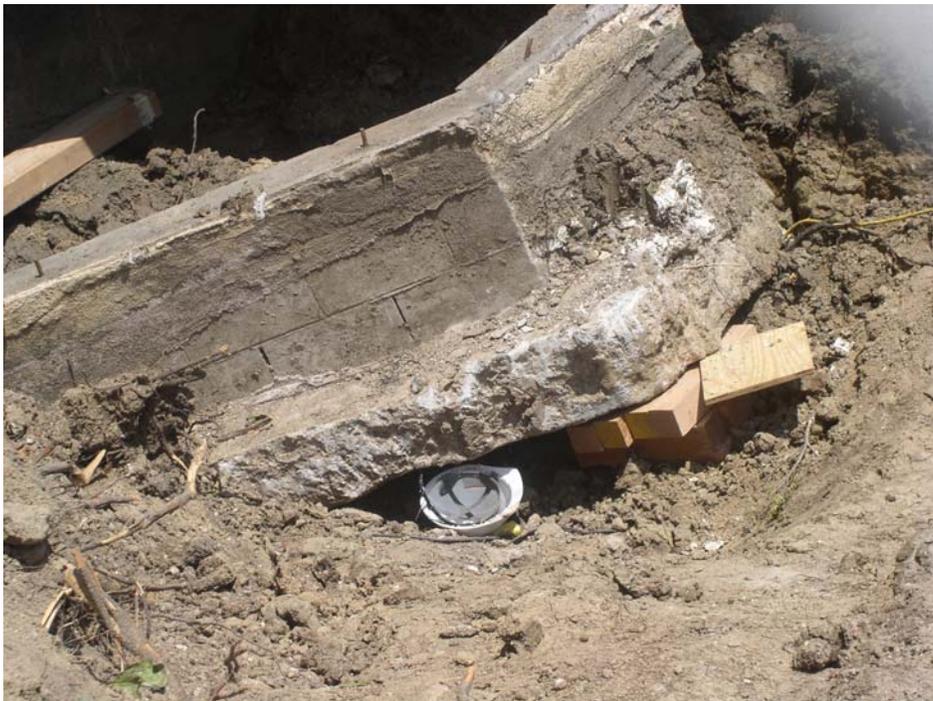
The cause of death according to the death certificate was mechanical asphyxia caused by compression of the torso from a large concrete block.

Exhibit #5. The concrete slab that fell on the victim.

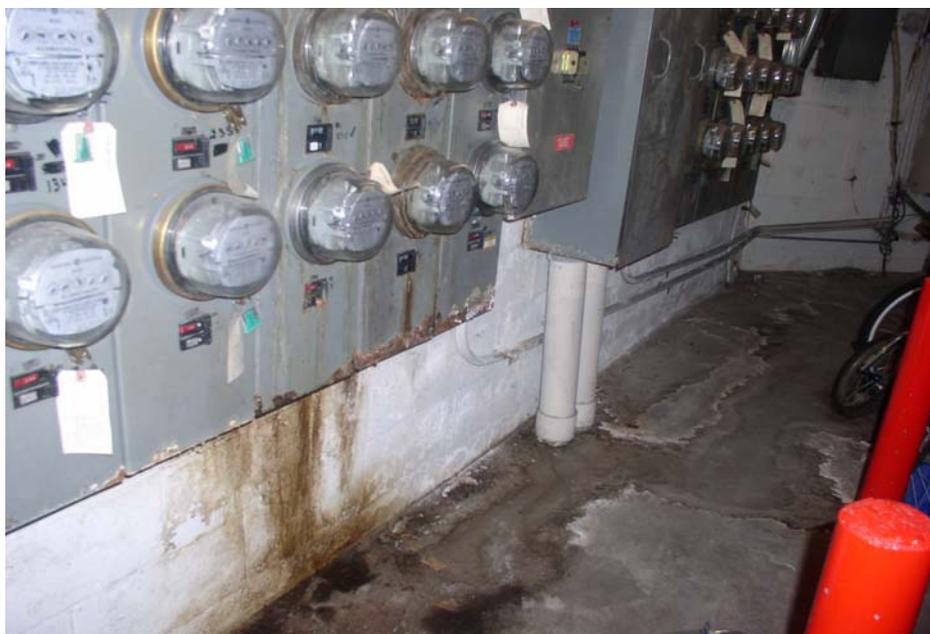
Exhibit #6. The water damage inside the apartment complex that warranted the waterproofing.
