SUBJECT: A helper on a steel-slitting machine died when caught in between some sheet

metal and the rewind cylinder

SUMMARY California FACE Report #05CA003

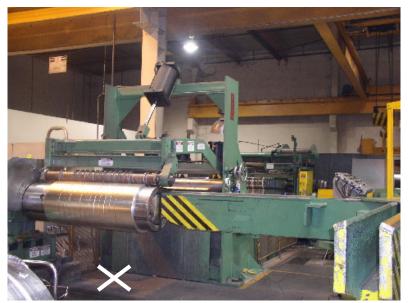
Exhibit 1: A picture of the slitter machine involved in the incident showing the cut steel being wound on the re-wind cylinder. The "X" marks the spot where the victim was caught in the steel sheet.

Recommendation #1: Ensure machines with moving parts are properly guarded.

Discussion: Machines with pinch points should have guarding for the time they are running. Because of the ever-present danger of entanglement when working near moving machinery, employers should continually strive to protect employees by providing machine guarding in the areas where work is actually performed. The machine involved in this case was operating with the guarding as it had been originally set up but some moving parts remained unguarded. Employers should consider contacting machine manufacturers and retrofit, if applicable, guards that prevent workers from contacting the machine's moving parts. Proper guarding and barricades strategically placed around all moving parts can prevent accidental contact.

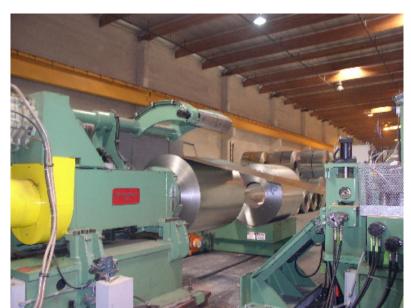
Exhibit 2: A picture of the rear of the slitter machine showing where the product is mounted on the machine, then fed into the knives for cutting.

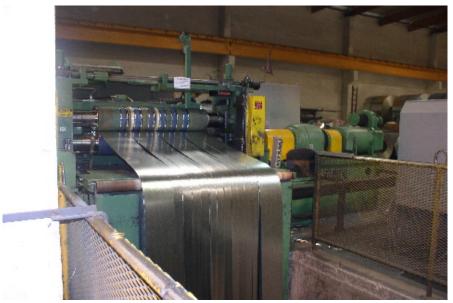
Exhibit 3: A picture of the slitter machine showing the product after it is cut into strips by the knives and then dropped into a pit to equalize the pressure on all strips.

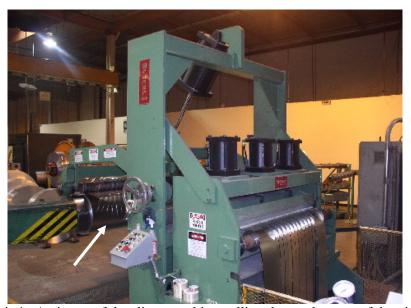
Exhibit 4: A picture of the slitter machine pulling the product out of the pit and feeding it onto the rewind cylinder. The arrow is pointing to the rewind cylinder.

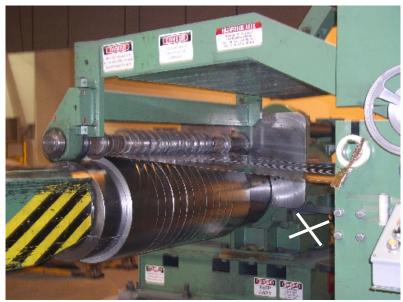
At approximately 7:45 p.m., the victim was picking up scrap pieces of material coming off the machine. This was part of his normal duties. His instructions were to pick up the scrap pieces that fell away from the machine while it was running, and not to reach into or go under the machine. Scrap formation was a normal byproduct of the process. As he was picking up the scrap, he placed himself underneath the machine where the product was being wound on the rewind cylinder. The employer said that this area was not supposed to be entered when the machine was running, but there was no guarding or barrier in place to prevent entry.

Exhibit 5: A picture of the product being wound on the rewind cylinder. The "X" marks the area where the victim entered the machine from the other side and got entangled in the cut steel sheet.

Recommendation #2: Ensure employees do not place any part of their bodies into areas where they might become entangled with machinery when it is running.

cuts it into strips for customer use, and then rewinds the finished product on another cylinder. All precautions need to be taken when working around this machine to prevent entanglement from occurring. Although guarding would normally protect workers from entanglement, as an additional layer of safety, employers should establish safety and training policies and maintain programs to ensure employees never place their bodies where they could become entangled in the pinch points of moving machines. Such programs may have helped to keep the victim away from the rewind cylinder while it was operating. If an employer determines that a machine must be capable of movement during some operation and determines that no guarding can be provided, then the employer needs to minimize the hazard by providing and requiring the use of extension tools or other methods or means to protect employees from injury due to such movement. Employees also need to be made familiar with the safe use and maintenance of such tools, methods, or means, by thorough training. Employers can enhance worker compliance with safe work practices through programs of task specific training, supervision, recognition, and progressive disciplinary measures.

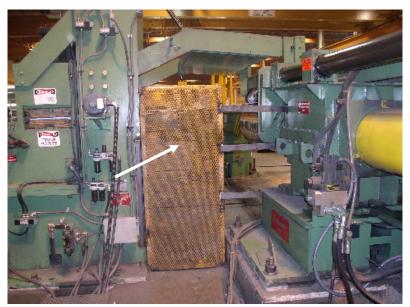
Exhibit 6: The arrow is pointing to the location where the victim went into the machine. The barricade was placed after the fatality.
