**FATALITY ASSESSMENT AND CONTROL EVALUATION
PROGRAM (CA/FACE)**

**A Bathtub Refinisher Dies from Methylene Chloride Exposure
While Removing Paint from a Bathtub
Case Report: 17CA002**

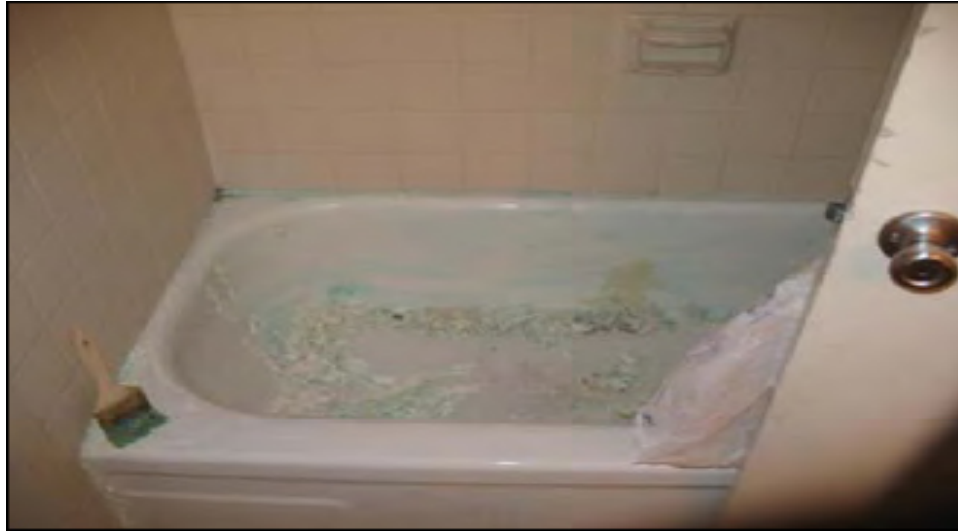
Exhibit 1. Photo of a similar bathtub being stripped of paint using a chemical paint remover (not the bathtub in this incident). *Photo courtesy of Michigan Fatality Assessment and Control Evaluation program.*
