**FATALITY ASSESSMENT AND CONTROL EVALUATION  
PROGRAM (CA/FACE)**

**A Tree Trimmer is Electrocuted While Trimming a Palm Tree  
Case Report: 18CA001**

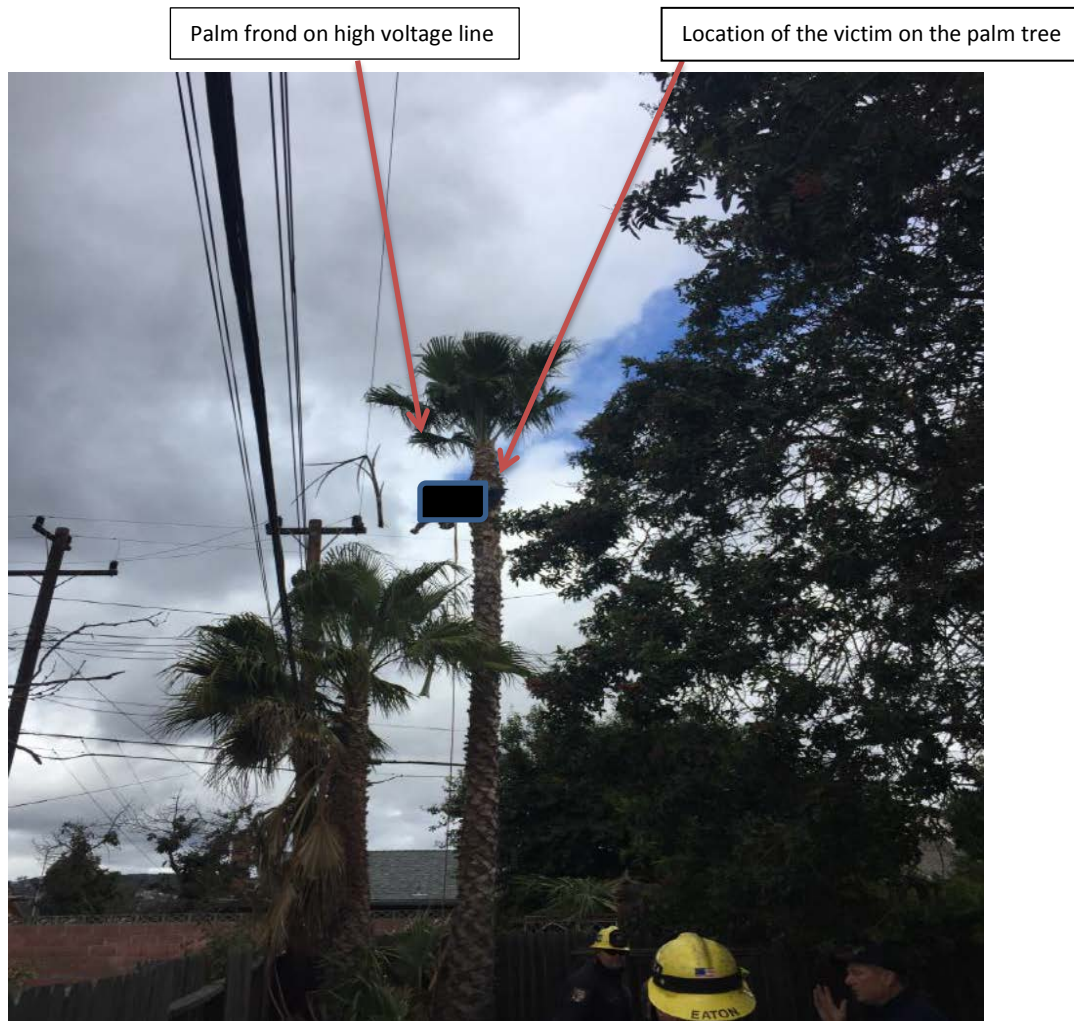
The incident scene was a private residence located on a short cul-de-sac street. The home was managed by a property management company that rented the residence to a private party. This property management company hired the employer of the victim to remove a pepper tree and trim all the palm trees in the front and back of the residence. The residence was a single-story building with an attached garage. The front of the house faced east and the back faced west. The back yard was rectangular in shape with a grass lawn bordered by flower beds and different planted vegetation of shrubs and trees. In the northwest corner of the back yard were three palm trees that had grown to different heights. The tallest tree (the tree involved in the incident) exceeded 50 feet in height and its fronds extended outward within 10 feet from high

voltage power lines. Also located in that corner of the yard was a utility pole that contained numerous communication lines as well as primary and secondary high voltage electrical lines.

Exhibit #1: The palm tree involved in the incident, and its close proximity to the high voltage electrical lines. *Photo used with permission.*

**Recommendation #2: Ensure that a qualified line clearance tree worker is used when tree trimming is within 10 feet of energized high voltage power lines.**

- Wearing insulated gloves and using insulated tools to prevent the flow of electricity if accidental contact is made.
- Using an insulated bucket truck to gain access to the work area, thereby preventing the direct path for electricity to the ground if accidental contact is made.
- Calling the utility company to have the line covered with insulated tubes or blankets or have the line de-energized for the duration of the job.

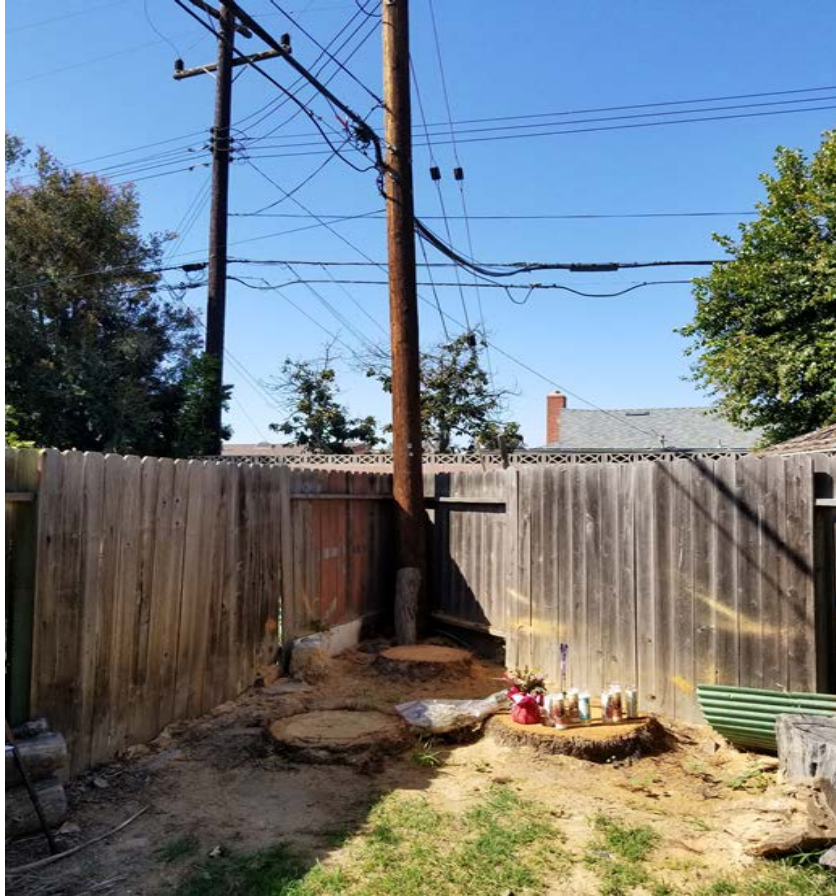
Exhibit #2. The incident scene showing the utility pole, and stumps where palm trees were cut down after the incident. The stump with the candles and flowers on it (a memorial to the victim) is the one involved in the incident. *Photo used with permission.*
