**FATALITY ASSESSMENT AND CONTROL EVALUATION  
PROGRAM (CA/FACE)**

**A Laborer Dies When He is Pulled into a Tree Stump Grinder  
Case Report: 18CA002**

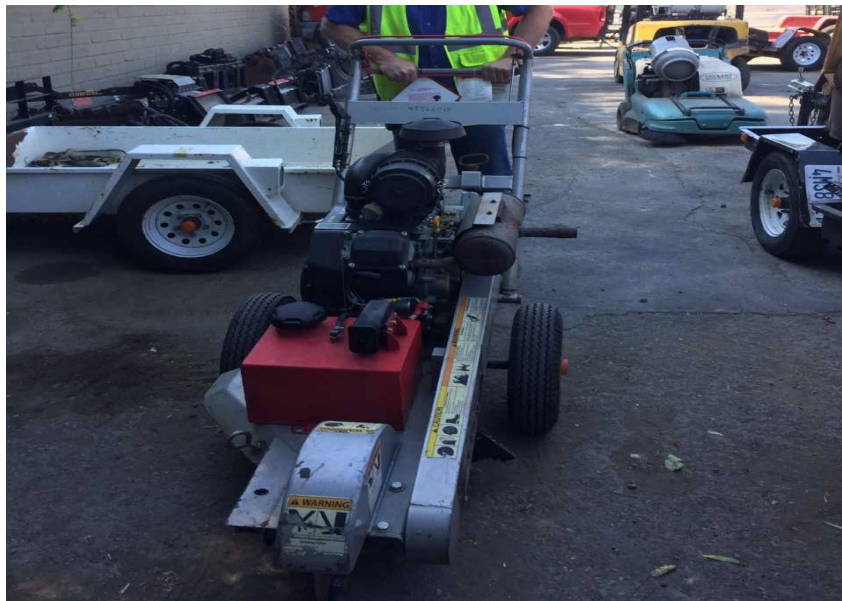
Prior to the day of the incident, the landscaping company owner was hired by the homeowner to remove the sycamore tree, stump, and roots in the front yard. The owner hired the victim to assist him with this job and rented a large stump grinder from a nearby tool rental company. They removed the major section of the sycamore tree stump and portion of the roots, but a portion of the stump and smaller roots remained below ground and could not be reached by the large stump grinder. The owner then returned the large stump grinder to the rental agency and rented a smaller stump grinder (Exhibits 1 and 2) that could be lowered below ground to reach the roots.

Exhibit #1. The stump grinder used in this incident.

**Recommendation #1: Ensure that workers who operate stump grinders are trained on and consistently follow safety policies and procedures.**

In addition, safety training should warn of the risk of entanglement when tying ropes or chains to a stump grinder. The operator and any worker who assists in the operation of a stump grinder should understand that ropes or chains should never be attached to a stump grinder while it is in operation. An eyehook or other attachment point should only be used for moving the machine (when off) and not for attachment of ropes or chains during operation.

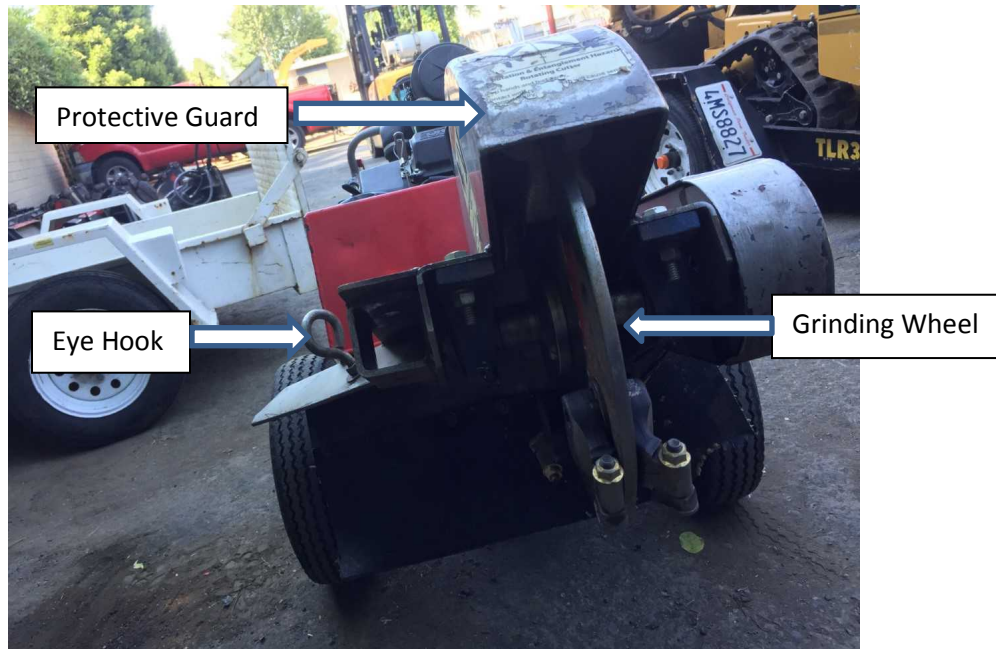
On the day of the incident, the owner and the victim attached a rope to an eye hook on the disc guard of the stump grinder (Exhibit 2) to help lower the machine below ground level to grind the stump and roots. The rope was not removed from the machine. The victim tied the rope around his waist, then pulled and leaned backward to help maneuver the grinding wheel while the owner was operating the stump grinder. A neighbor from across the street stated the victim was standing near the edge of the stump cavity. As the grinder was operating, the rope likely became slack and then caught around the grinding wheel, pulling the victim headfirst into the rotating disc.

Exhibit #2. A front view of the stump grinder used in this incident, showing the grinding wheel and protective guard covering the wheel.
